National Parks & Wildlife Service

**Crosswood Bog SAC
(Site code 002337)**

Raised Bog Restoration Plan (Report)

October 2022

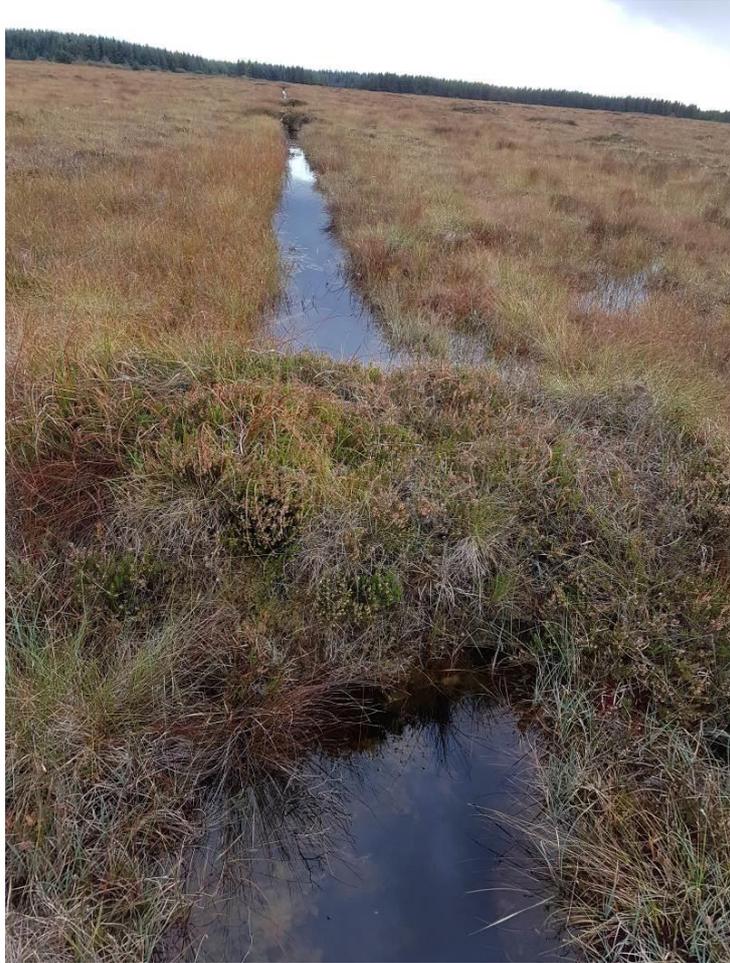
Figure 2.1 Example of a peat dam to block a typical high bog drain

Blocking high bog drains slows the flow of water off the surface of the bog and increases the water table in the peat. Drain blocking is a proven and effective restoration measure on Irish raised bogs with minimal maintenance requirements. The approach has been demonstrated at a number of raised bogs in Ireland with very positive results evident in less than 10 years (**Figure 2.1**) as outlined by Fernandez *et al.* (2014a).

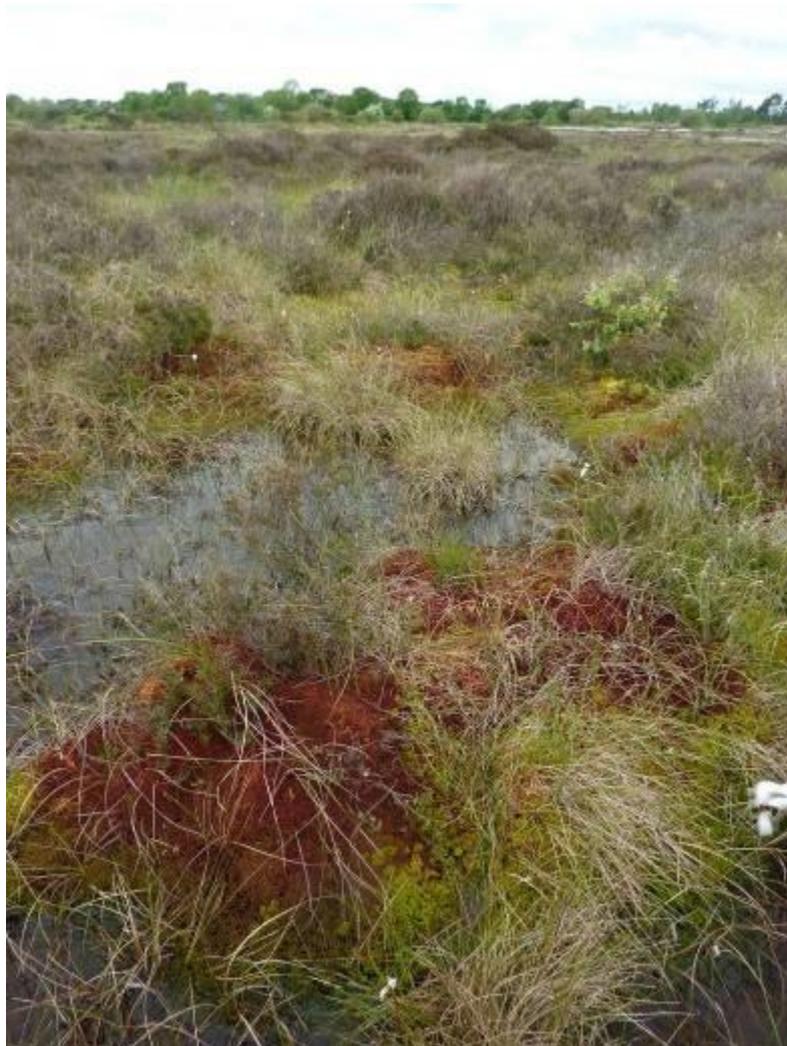
Figure 2.2 Water table at the surface of cutover bog following successful drain blocking resulting in *Sphagnum* development less than 10 years after drain blocking (this was previously an area of bare peat)

Blocking of cutover drains slows the flow of water off the cutover areas and increases the water table in the surrounding peat. This can help to reduce the rate of infiltration through the high bog and can lead to conditions that allow peat to form on the cutover (**Figure 2.2**).

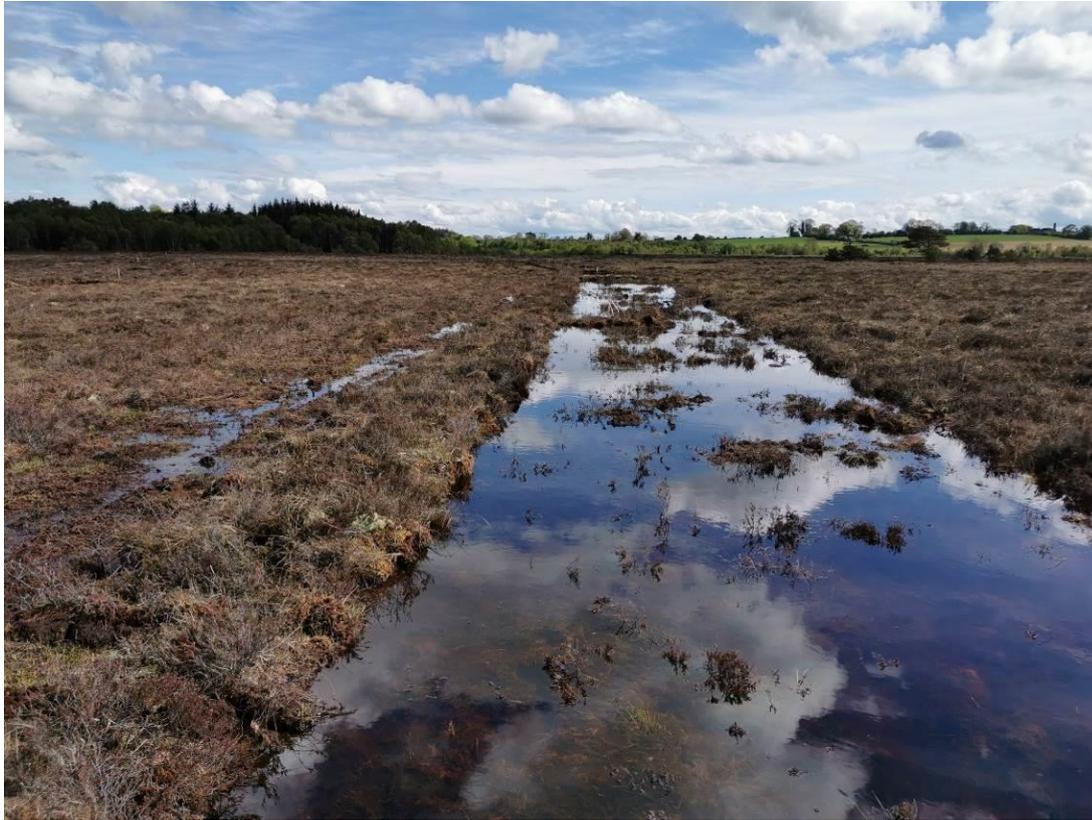
Figure 2.3 Contour bund constructed at Knockacoller Bog SAC, Co. Laois

Contour bunds on the high bog aims to reduce the rate of lateral flow through the upper layers of the peat. In contrast to some other bunding techniques, contour bunding is not intended as a means of impounding surface water. This method involves excavating a trench 1.5-2.0m deep, re-

compacting peat into the trench and building a slightly raised bund 25-30cm above the current ground surface. In addition, these bunds have 5m long ‘finger bunds’ constructed using the same technique at approximately 25m spacing to prevent flow along the bund which may lead to erosion. After 1-2 years it is anticipated that the bund will have subsided close to current ground level and therefore will not appear as a prominent feature on the bog surface.

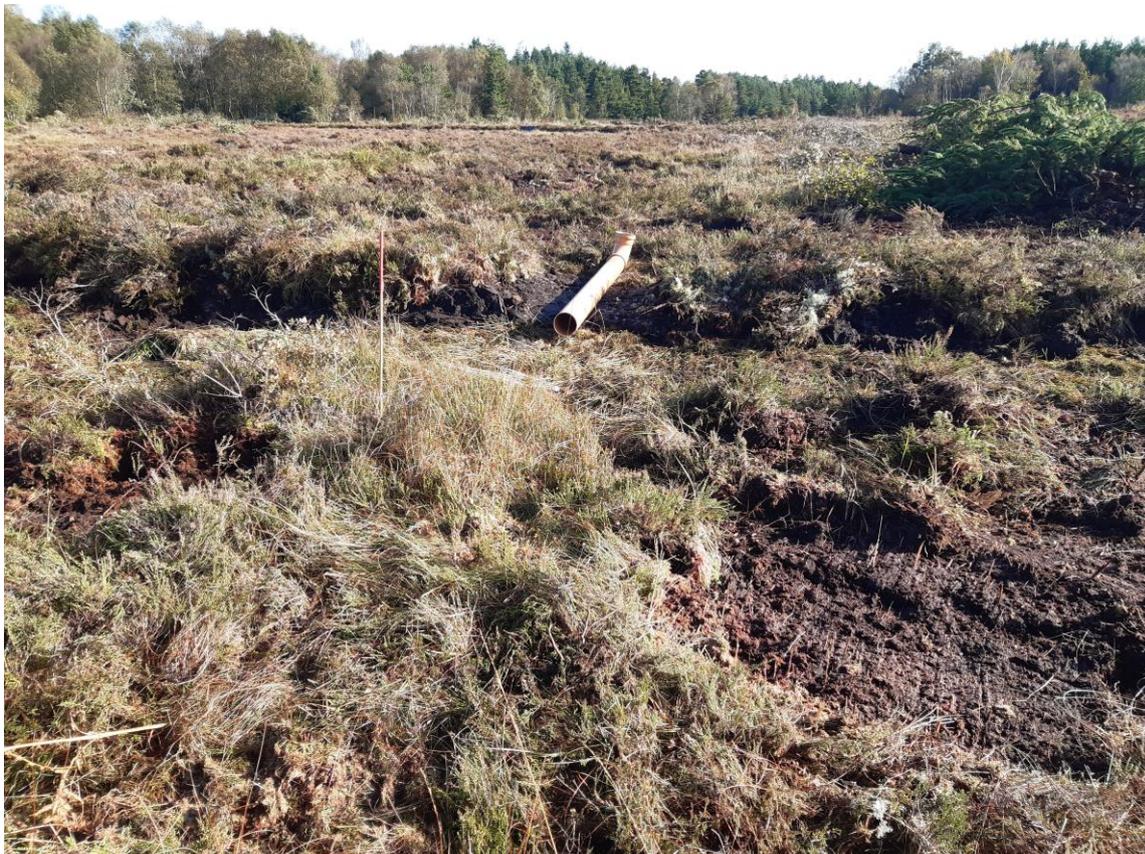
Figure 5.3 Example of setting out for piped weirs in a trench bund on the cutover. The bamboo is sprayed red

The surveying and staking out of drains and dams can be difficult due to the nature of the bog environment. Vegetation and soft ground conditions can make identification of features and surveying of same difficult and potentially dangerous. The setting out of the Works is generally done using bamboo stakes to mark the locations of the restoration measures that are to be constructed such as the dams or bunds. All Works proposed during phase 1 of the restoration plan were set out as required. This activity provides an additional opportunity to review the restoration measures in detail on the ground and where necessary minor modifications can be made (e.g., adjusting the placement of particular dams due to dense vegetation coverage or alignment of bunds due to ground conditions). This ensures that the risk of damage to the raised bog is minimized as inadequate planning can increase the risk of machines entering unsuitable areas.

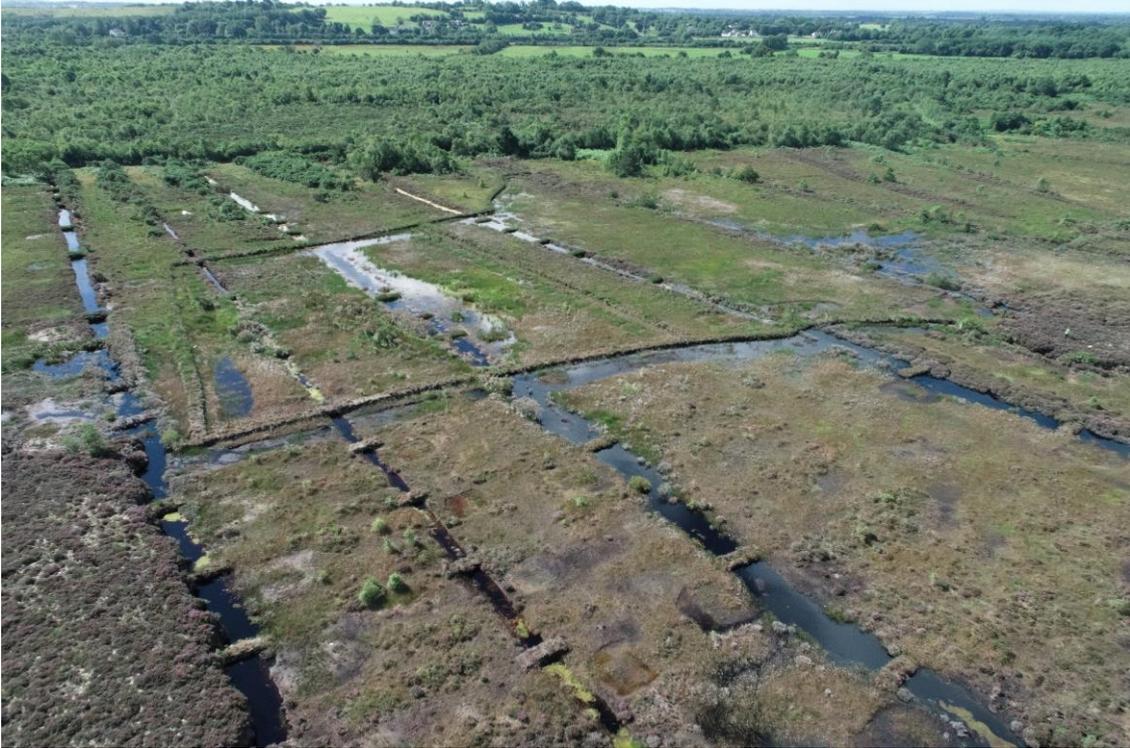
Figure 5.5 Example of high-resolution ortho-imagery illustrating peat dams on the cutover

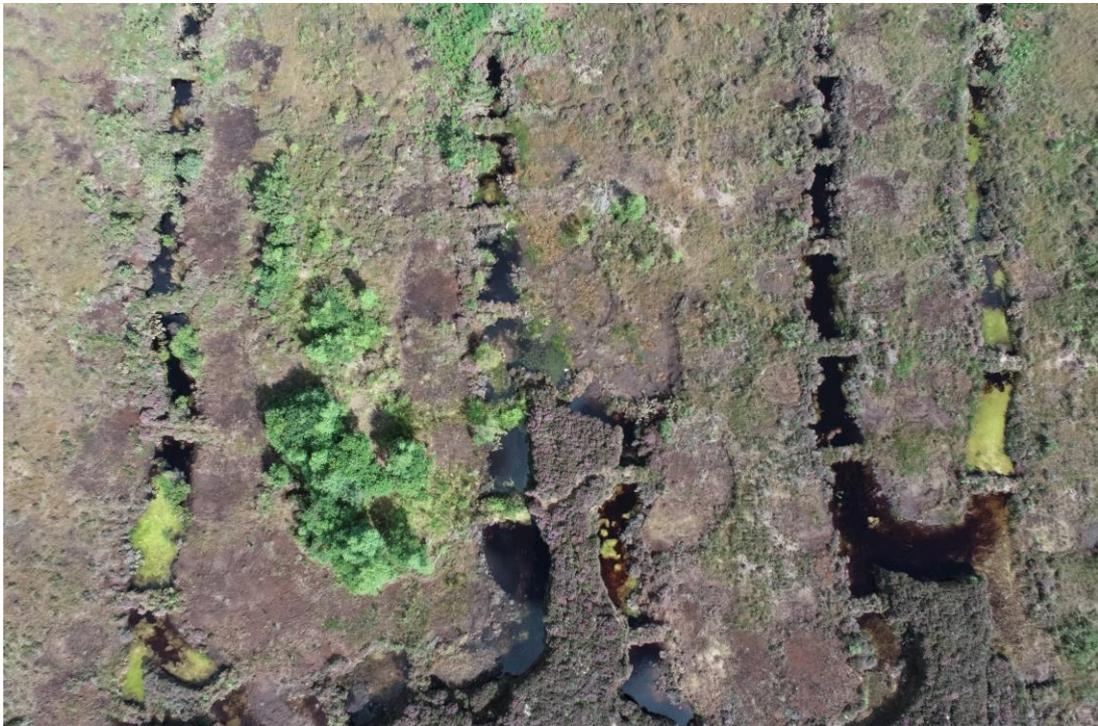
Figure 5.6 Example of cell bunding on the cutover bog illustrating water table close to the ground surface
