National Parks & Wildlife Service

**Ferbane Bog SAC**  
**(Site code 000575)**

**Raised Bog Restoration Plan (Report)**

October 2022

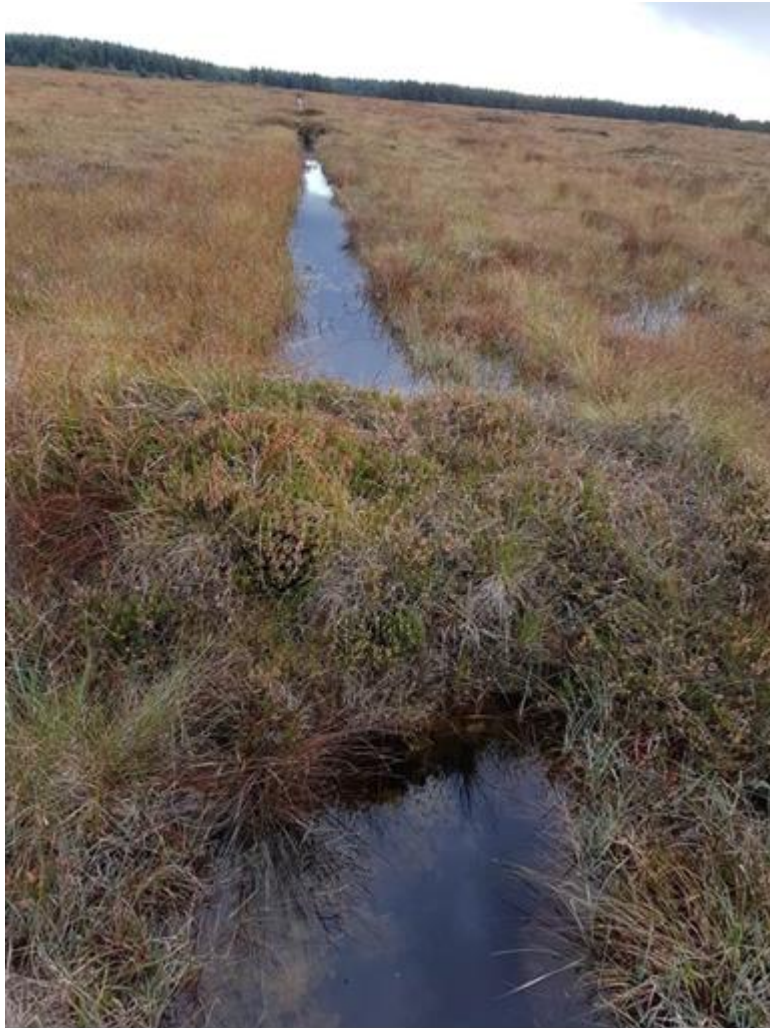
**Figure 2.1** Example of a peat dam used to block a typical high bog drain.

Blocking high bog drains slows the flow of water off the surface of the bog and increases the water table in the peat. Drain blocking is a proven and effective restoration measure on Irish raised bogs with minimal maintenance requirements. The approach has been demonstrated at a number of raised bogs in Ireland with very positive results evident in less than 10 years (**Figure 2.1**) as outlined by Fernandez *et al.* (2014b).

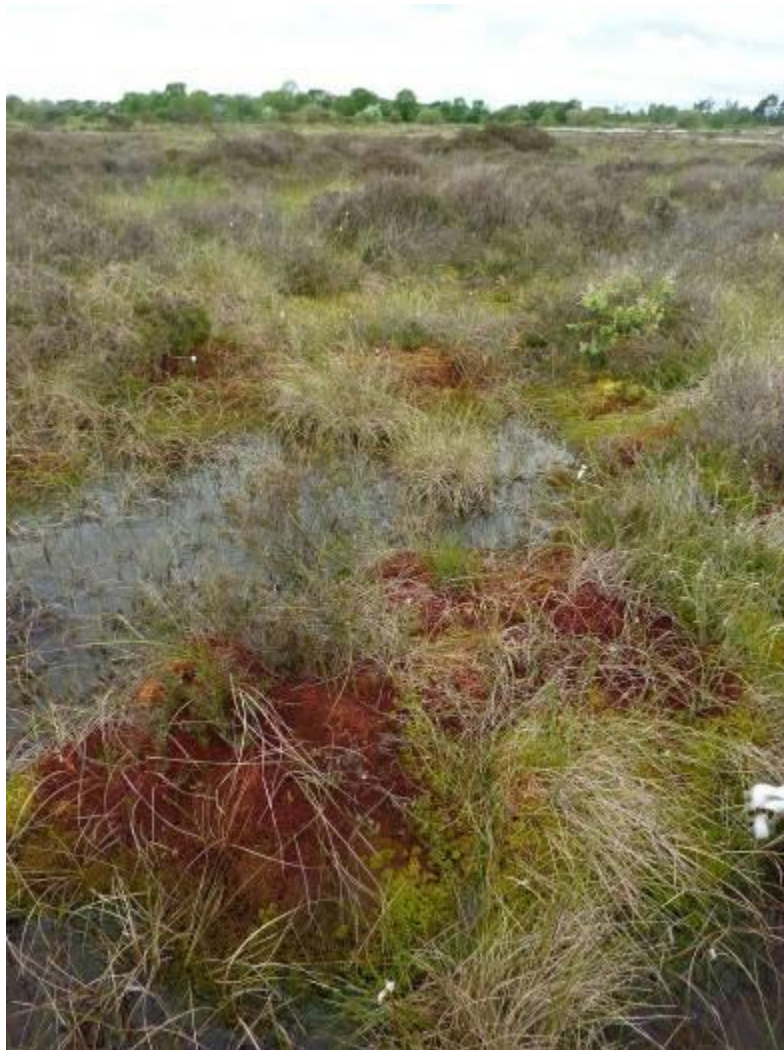
**Figure 2.2** Water table at the surface of cutover bog following successful drain blocking resulting in *Sphagnum* development less than 10 years after drain blocking (this was previously an area of bare peat)

Blocking of cutover drains slows the flow of water off the cutover areas and increases the water table in the surrounding peat. This can help to reduce the rate of infiltration through the high bog and can lead to conditions that allow peat to form on the cutover (**Figure 2.2**).

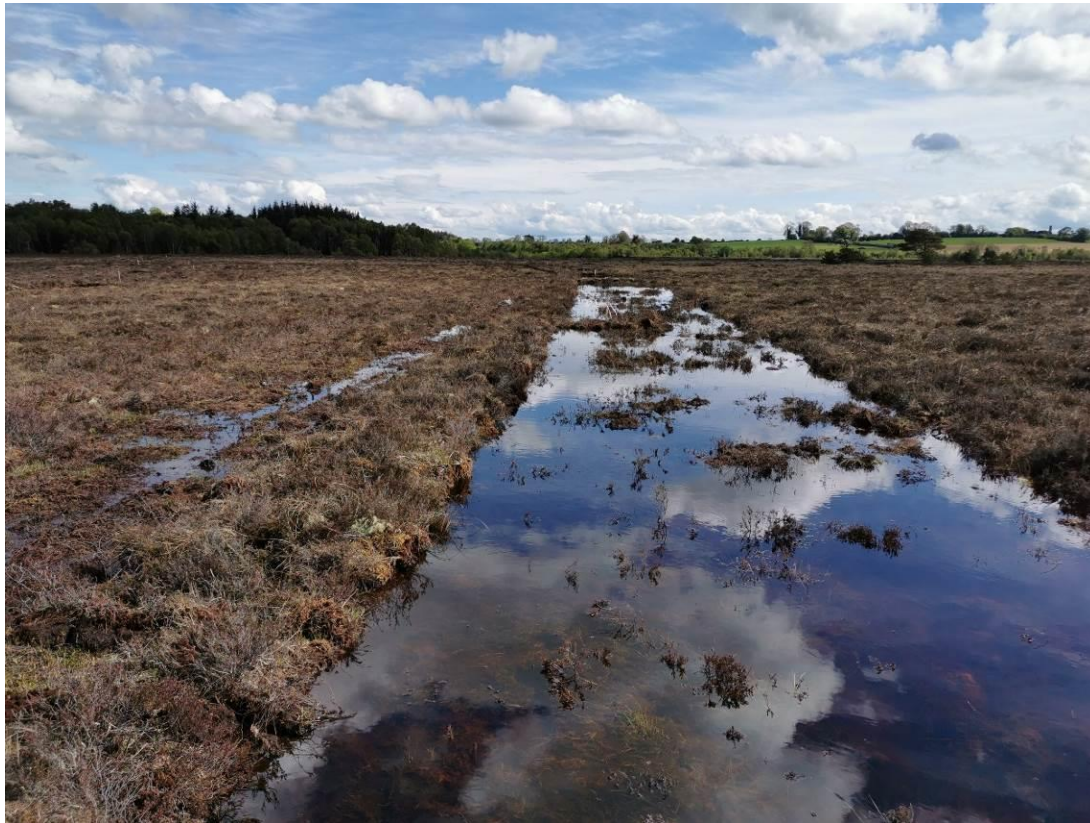
**Figure 2.3 Contour bund constructed at Knockacoller Bog SAC, Co. Laois**

the peat. In contrast to some other bunding techniques, contour bunding is not intended as a means of impounding surface water. This method involves excavating a trench 1.5-2.0m deep, re-compacting peat into the trench and building a slightly raised bund 25-30cm above the current ground surface. In addition, these bunds have 5m long 'finger bunds' constructed using the same technique at approximately 25m spacing to prevent flow along the bund which may lead to erosion. After 1-2 years it is anticipated that the bund will have subsided close to current ground level and therefore will not appear as a prominent feature on the bog surface.

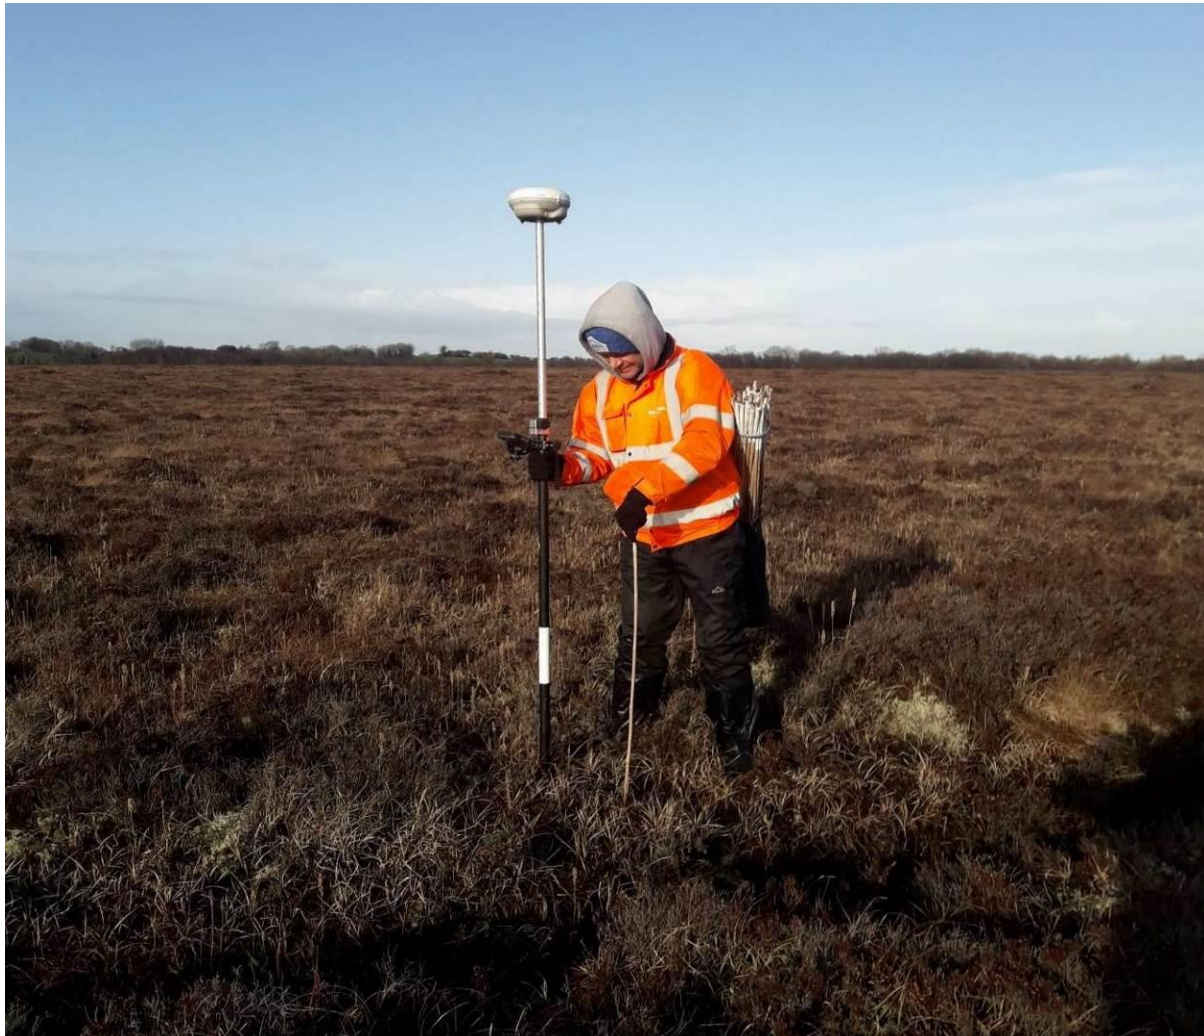
**Figure 5.5 Example of Surveyor setting out on a high bog**

The surveying and staking out of drains and dams can be difficult due to the nature of the bog environment. Vegetation and soft ground conditions can make identification of features and surveying of same difficult and potentially dangerous. The setting out of the Works is generally done using bamboo stakes to mark the locations of the restoration measures that are to be constructed such as the dams or bunds. All Works carried out as part of the Living Bog Project of the restoration

plan were set out as required which facilitated work being completed. This activity provides an additional opportunity to review the restoration measures in detail on the ground and where necessary minor modifications can be made (e.g., adjusting the placement of particular dams due to dense vegetation coverage or alignment of bunds due to ground conditions). This ensure that the risk of damage to the raised bog is minimized as inadequate planning can increase the risk of machines entering unsuitable areas.

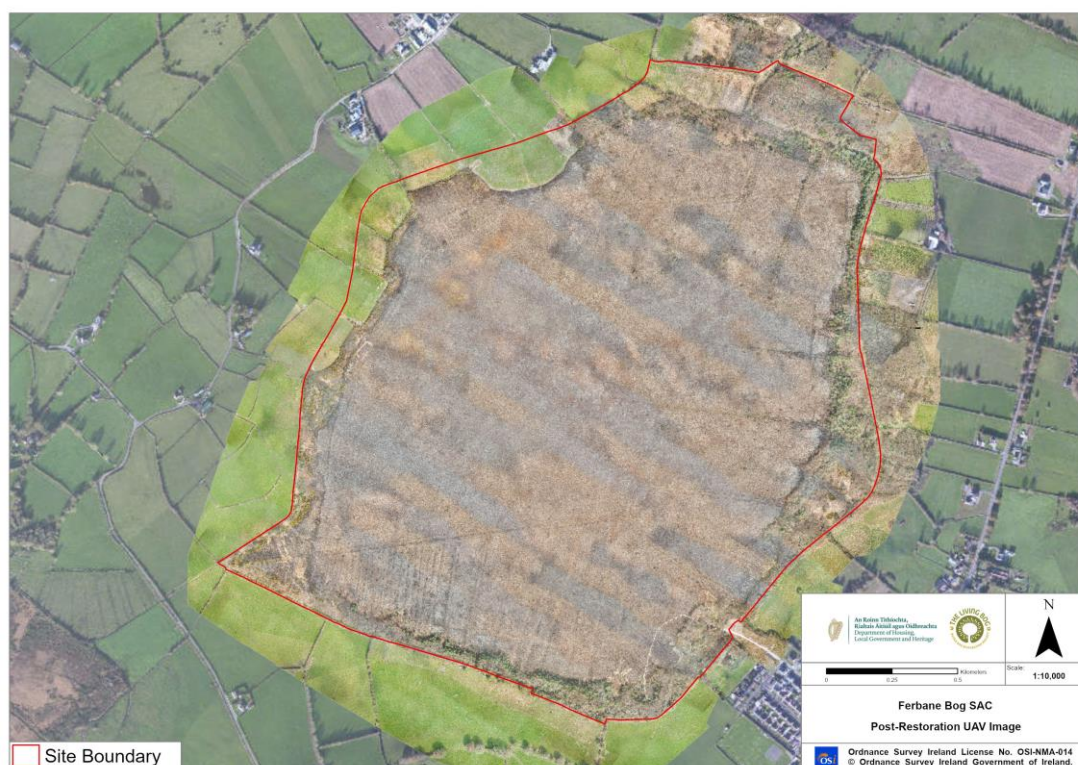
**Figure 5.7 High resolution post-Works ortho imagery from UAV survey**

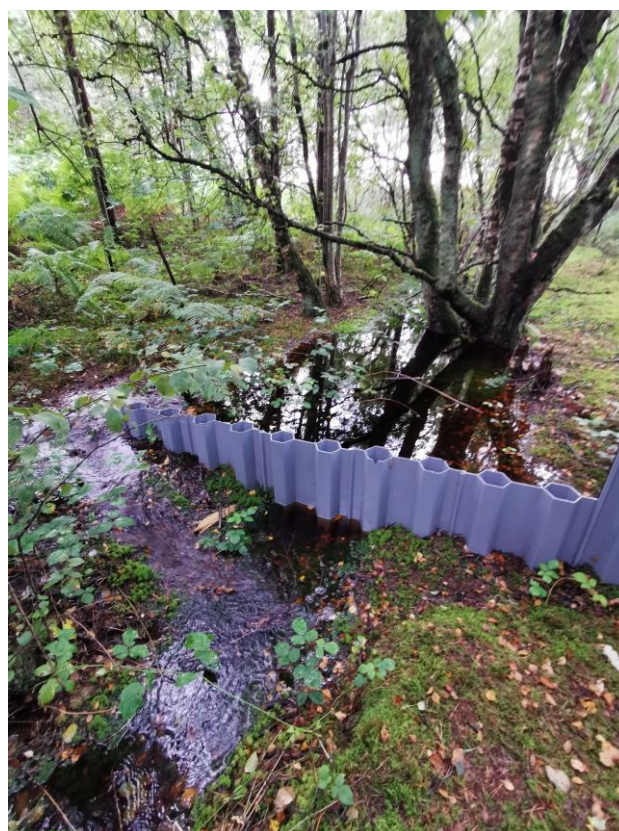
**Figure 5.8 Example of targeted blocking of drains with plastic dams in densely wooded areas**

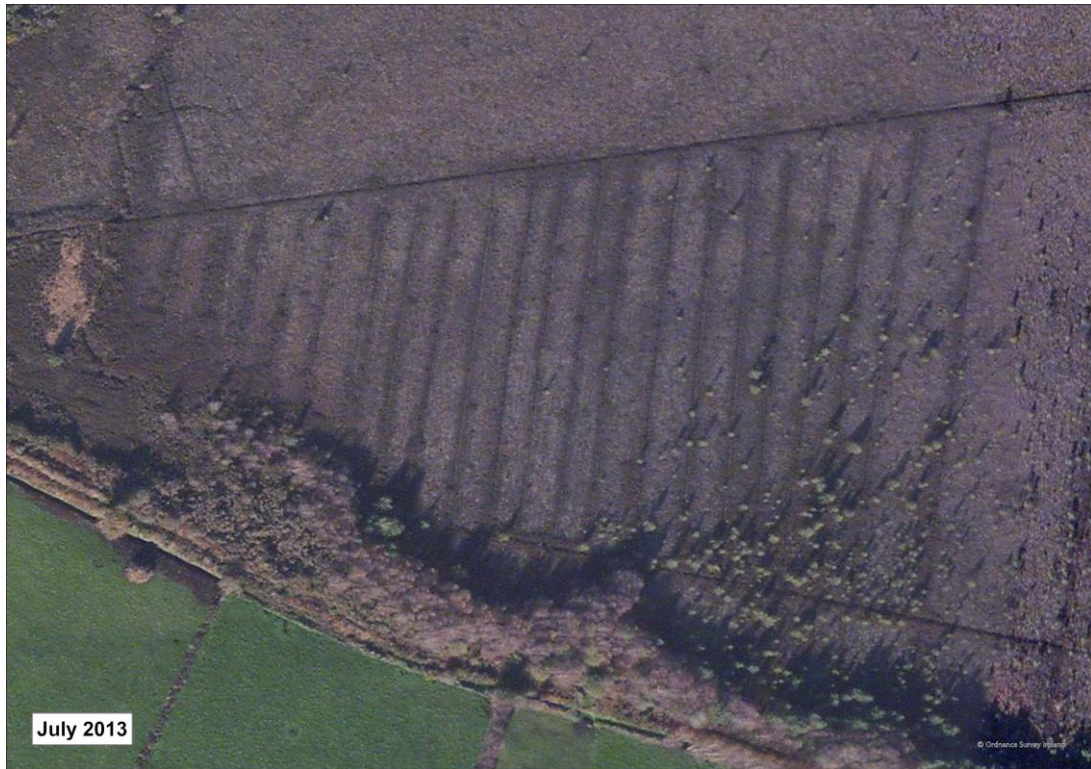
Figure 5.9 Pre-Restoration ortho imagery at Ferbane Bog SAC

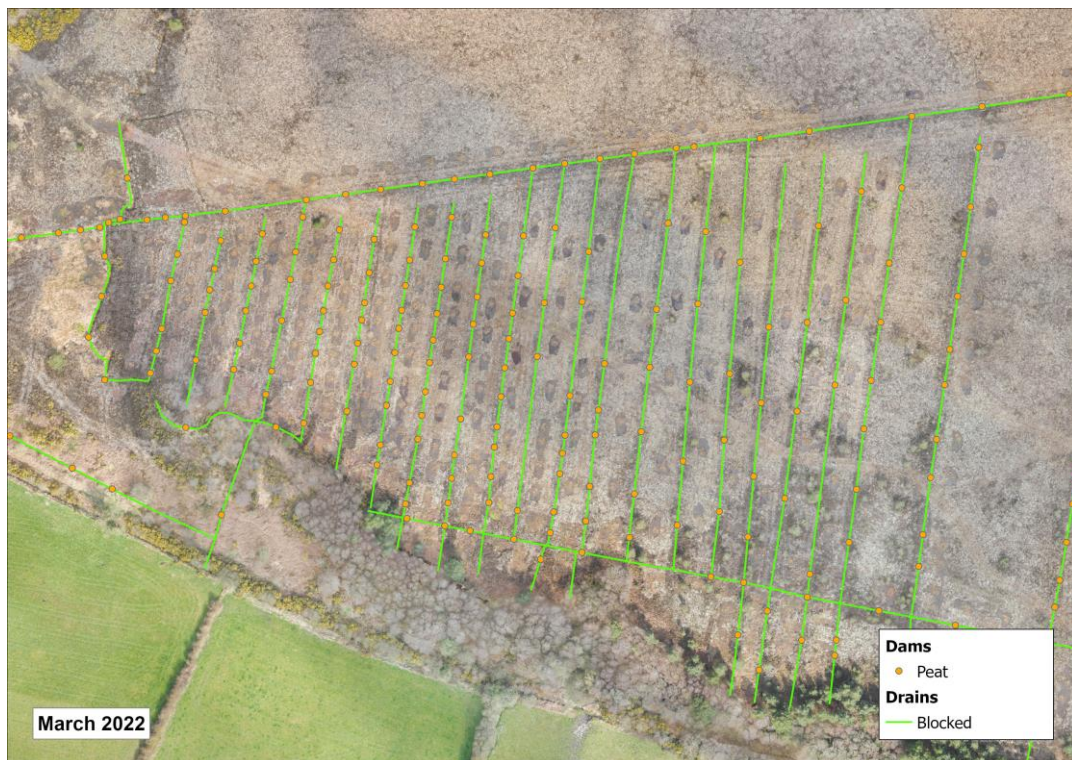
Figure 5.10 Post-Restoration ortho imagery at Ferbane Bog SAC

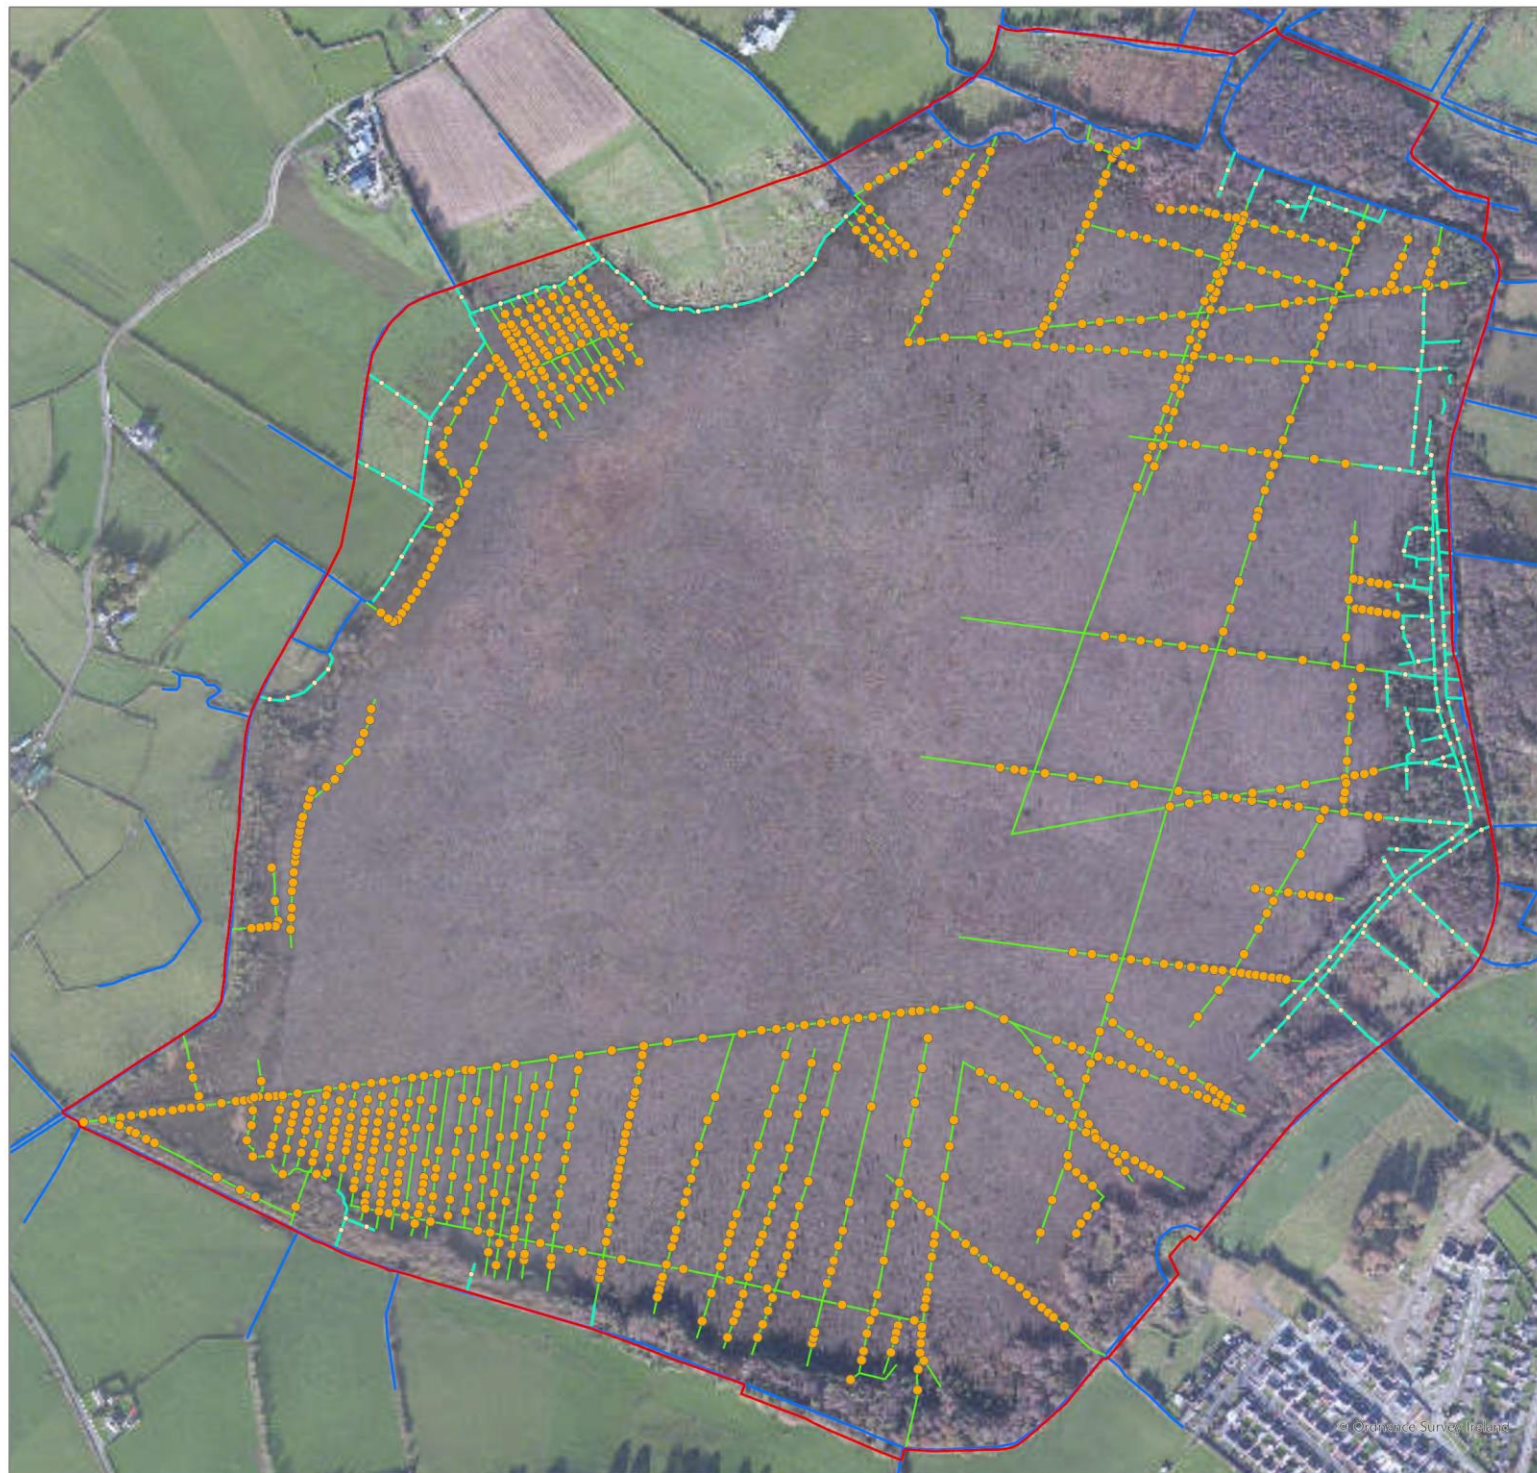
Site Boundary

### Dams

Map 1 outlines the location and extent of Ferbane Bog SAC. Map 2 illustrates the restoration measures that have been implemented to date as well as any proposed/outstanding restoration measures to be implemented at Ferbane Bog.

All high bog drains have been blocked on Ferbane Bog. However, ongoing monitoring of the drain blocking activity is required to ensure dams do not fail over time. Details of the locations of blocked drains on the high bog can be found in Map 2
