National Parks & Wildlife Service

Killyconny Bog (Cloghbally) SAC
(Site code 000006)

Raised Bog Restoration Plan (Report)

October 2022

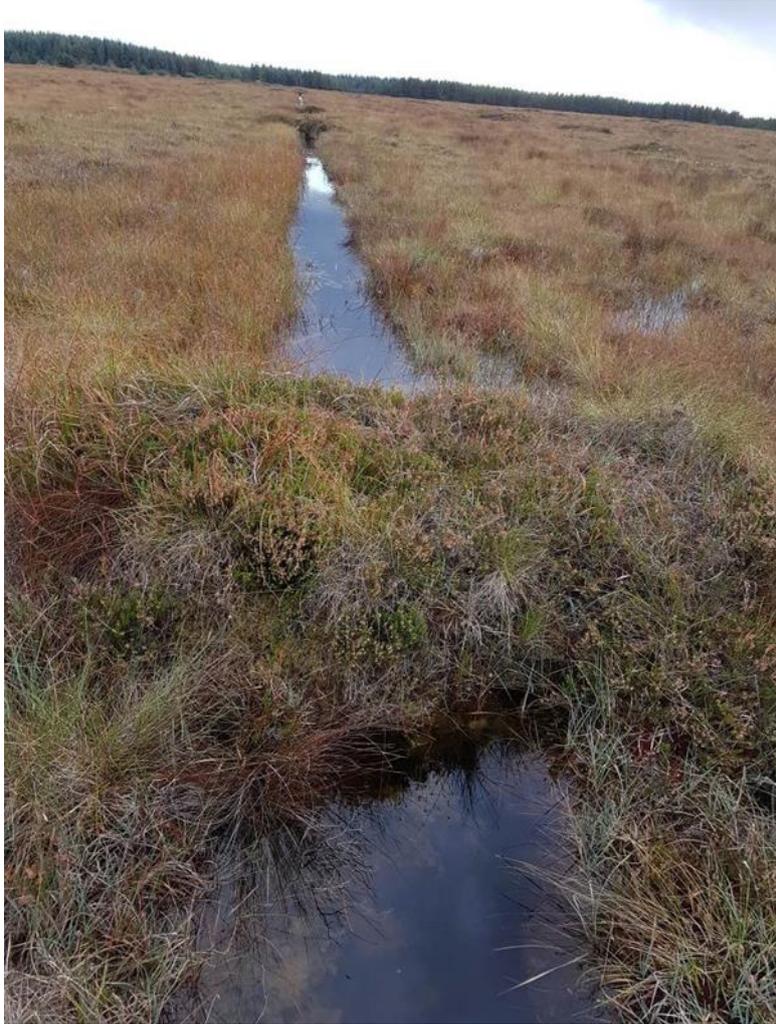
Figure 2.1 Overgrown peat dams showing *Sphagnum* regeneration above a dam

Blocking high bog drains slows the flow of water off the surface of the bog and increases the water table in the peat. Drain blocking is a proven and effective restoration measure on Irish raised bogs with minimal maintenance requirements. The approach has been demonstrated at a number of raised bogs in Ireland with very positive results evident in less than 10 years (**Figure 2.1**) as outlined by Fernandez *et al.* (2014a).

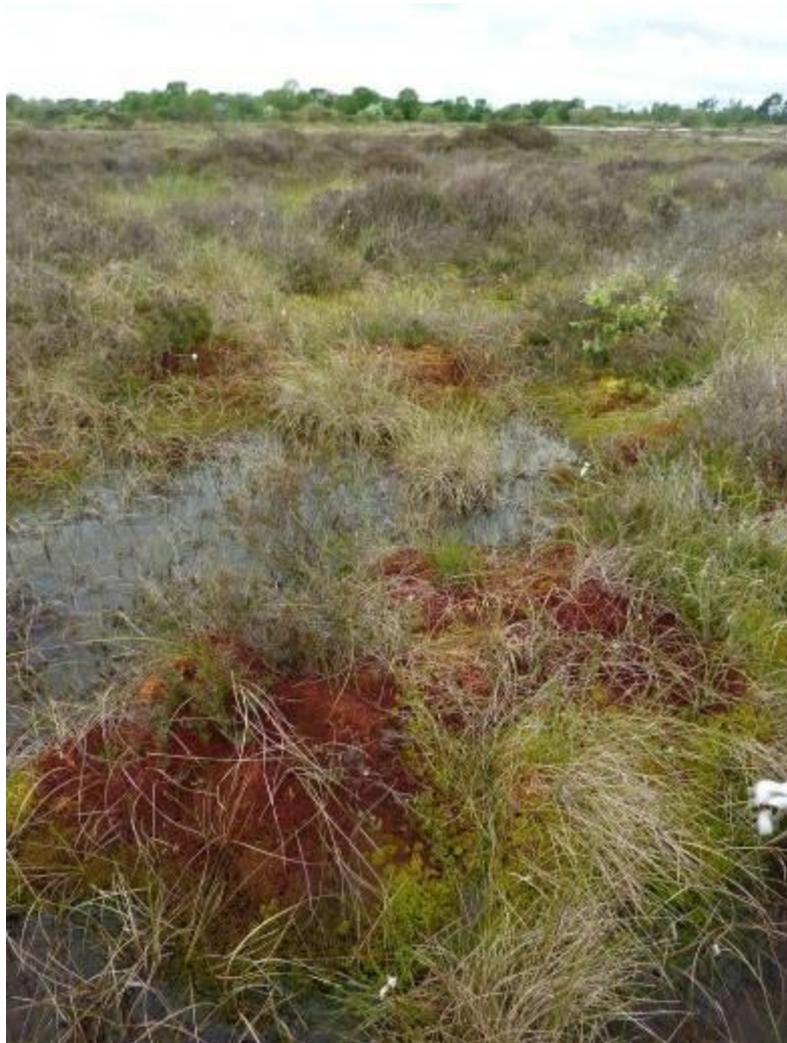
Figure 2.2 Water table at the surface of cutover bog in Killyconny following successful drain blocking resulting in *Sphagnum* development less than 10 years after drain blocking (this was previously an area of bare peat)

Blocking of cutover drains slows the flow of water off the cutover areas and increases the water table in the surrounding peat. This can help to reduce the rate of infiltration through the high bog and can lead to conditions that allow peat to form on the cutover (**Figure 2.2**).

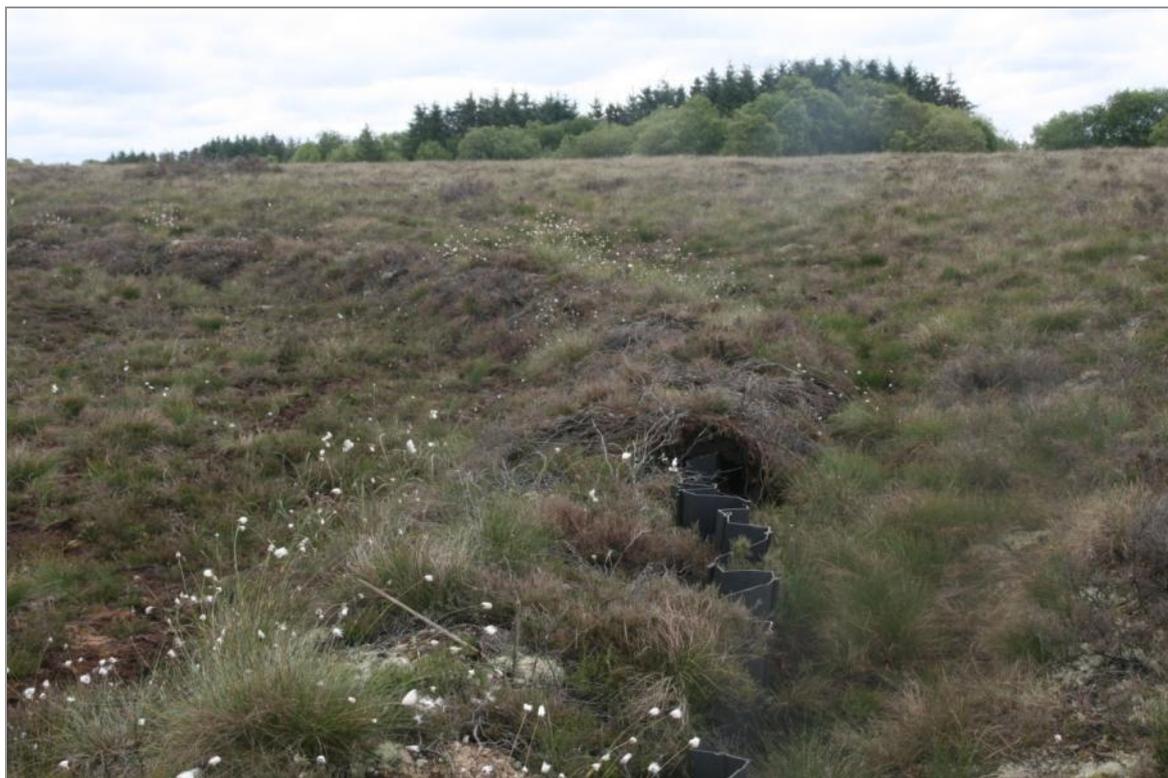
Figure 2.3 Example of a contour bund constructed at Killyconny Bog SAC

Contour bunds on the high bog aims to reduce the rate of lateral flow through the upper layers of the peat. In contrast to some other bunding techniques, contour bunding is not intended as a means of impounding surface water. This method involves excavating a trench 1.5-2.0m deep, re-compacting peat into the trench and building a slightly raised bund 25-30cm above the current ground surface. In addition, these bunds have 5m long 'finger bunds' constructed using the same technique at approximately 25m spacing to prevent flow along the bund which may lead to erosion. After 1-2 years it is anticipated that the bund will have subsided close to current ground level and therefore will not appear as a prominent feature on the bog surface.

Contour bunds are most effective where there is cracking or slumping in the upper layers of the peat as the re-compacted trench assists in sealing up these cracks and slows the flow rate through the peat, supporting a higher water table behind the bund. The key issue with this technique is that the extent of the impact extending back into the bog depends on the hydraulic gradient (which is closely correlated to surface slope). As a result, the extent of impact from such bunds is likely to be extremely limited where the surface slope at the margins is steep. This method is best suited to sites with a relatively gentle slope towards the margins or as a means of effectively blocking a dense network of shallow surface drains on the high bog. Ground conditions will play an important factor in whether the bund can be constructed in such circumstances, therefore this method is most effective on drier sites where machines can operate safely and effectively.

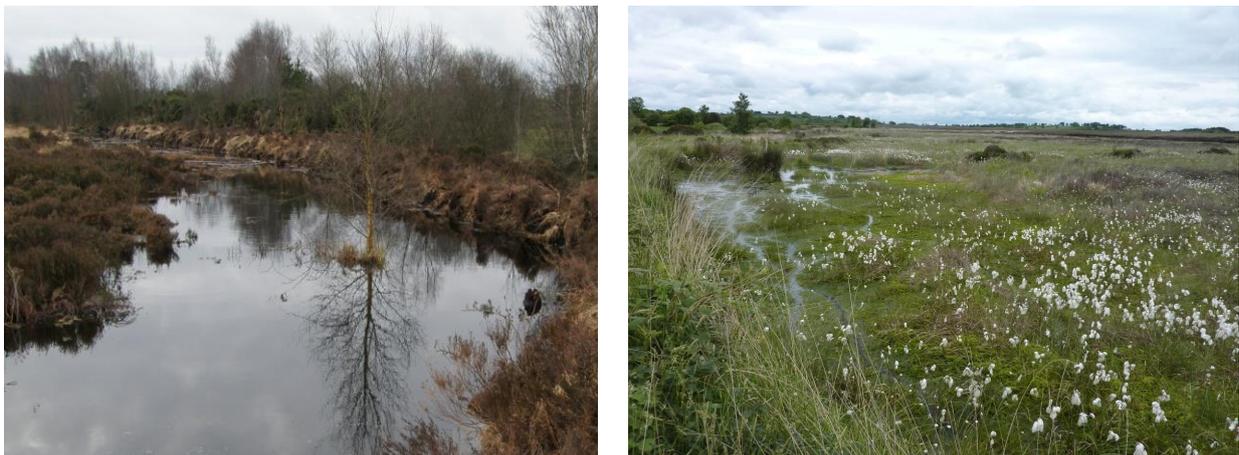
Figure 2.4 Example of vegetation response to construction of a large marginal bund at Killyconny Bog SAC. Left shortly after construction in 2008, Right: vegetation development in 2014.

An early example of cell bunding was trialled at Killyconny Bog SAC. This involved the construction of a single large marginal bund at the edge of the cutover. The slopes on the cutover at Killyconny are very gentle, resulting in a very positive impact from the construction of the bund as reported by Crowley et al. (2021) and illustrated in Figure 2.4. Their study demonstrated that 5.0ha of *Sphagnum*-rich regenerating bog vegetation has developed across the 26.9ha study site since restoration Works were implemented. The study also noted the key importance of topography in determining restoration potential, as extremely fine variations in topography resulted in significant differences in the vegetation that has developed.

The trial at Killyconny was extremely successful in improving conditions on the cutover but has also provided significant knowledge and understanding to be able to refine the method for application at

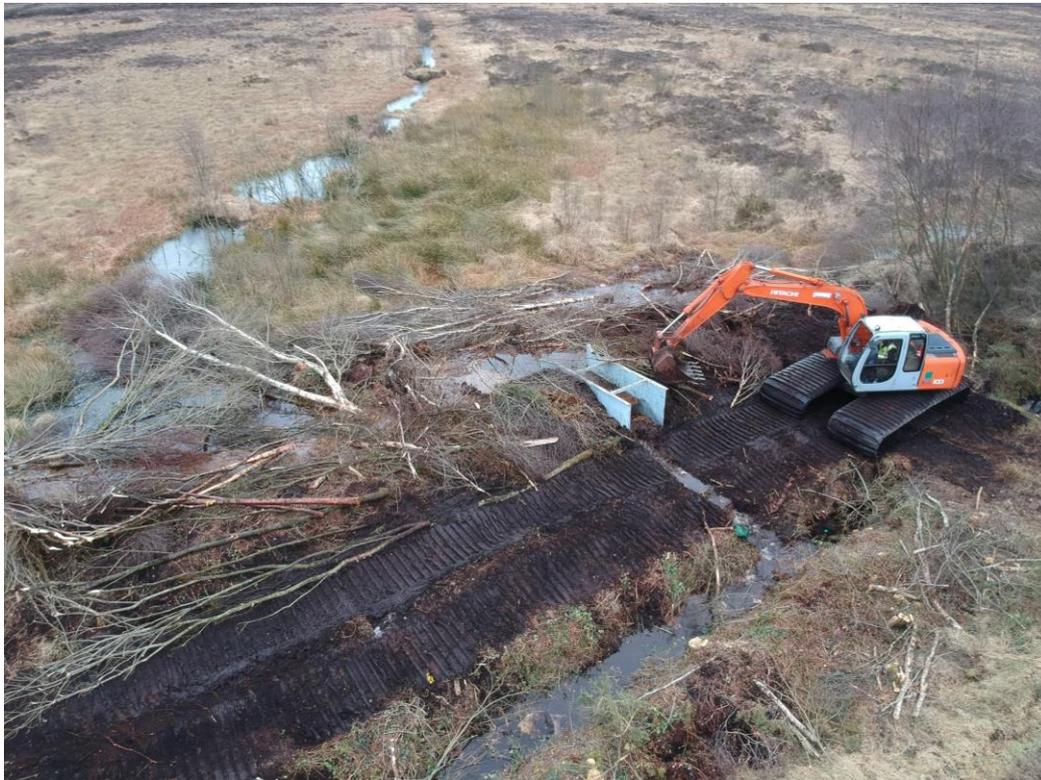
Figure 2.5 New outlet being installed in a large marginal at Killyconny Bog.

other sites. Some of the key learnings from this trial was the need to design bunding measures according to the topography, which is why all bunding is now designed initially using LiDAR data and where necessary, designs refined on the ground with high accuracy GPS units. In addition, the need for finger bunds is apparent as well as the benefits of creating small cells to minimize wave action and reduce the reliance on a single outflow point. As part of the Living Bog project, the outlets from the marginal bund at Killyconny were replaced by much more robust structures that allowed water levels to be maintained at target levels.

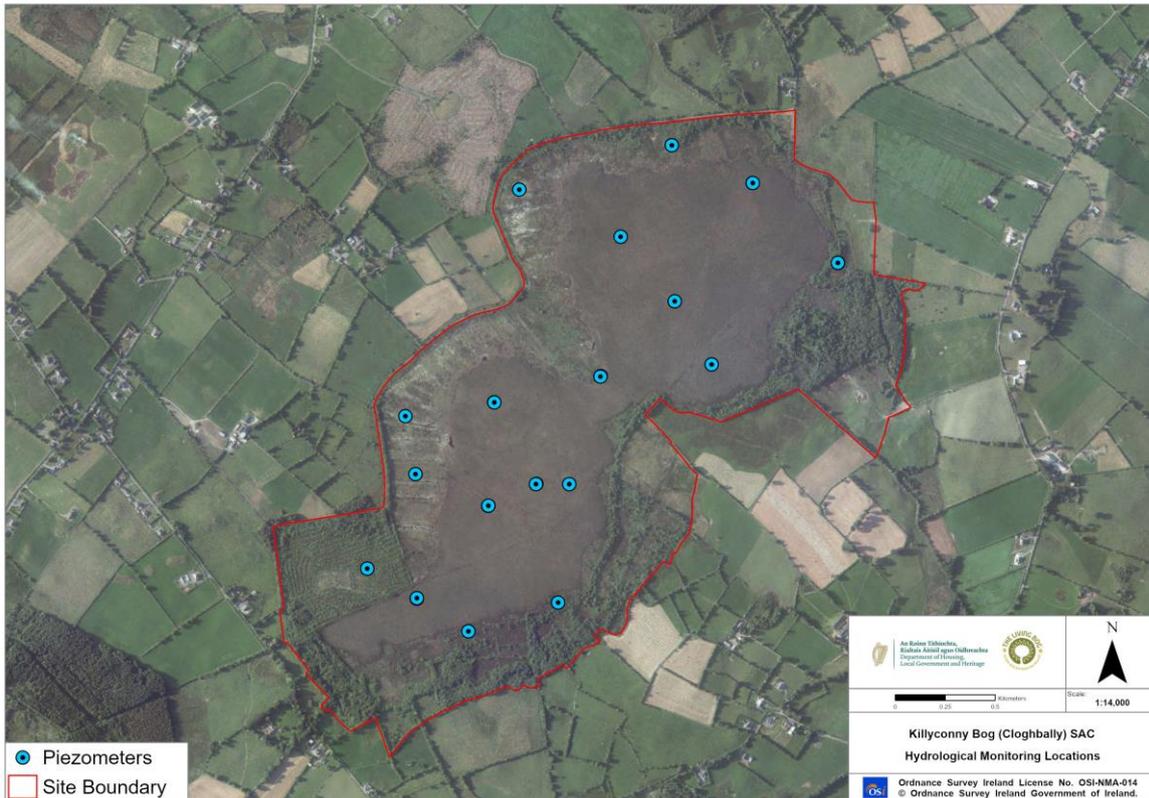
Figure 5.1 Location of hydrological monitoring network at Killyconny Bog SAC

Detailed hydrological characterisation of Killyconny Bog SAC was carried out in 2018 as part of the Living Bog Project. This comprised of detailed surveys of the high bog and cutover to collect data to enable the restoration plan to be refined. A detailed hydrological monitoring network was established in 2018, comprising 18 phreatic monitoring wells and 8 deep piezometers to monitor vertical hydraulic gradients. All wells were monitored manually at monthly intervals, with a subset of 4 monitoring wells instrumented with automated data logging equipment. This enabled the collection of baseline data to inform restoration plan design as well as assess the hydrological impact of restoration measures. This information was used as a feedback mechanism in reviewing the restoration plan. Targeted monitoring is ongoing as part of the AfterLIFE plan of the Living Bog project which will continue until 2027 (Cushnan & Crowley, 2022).

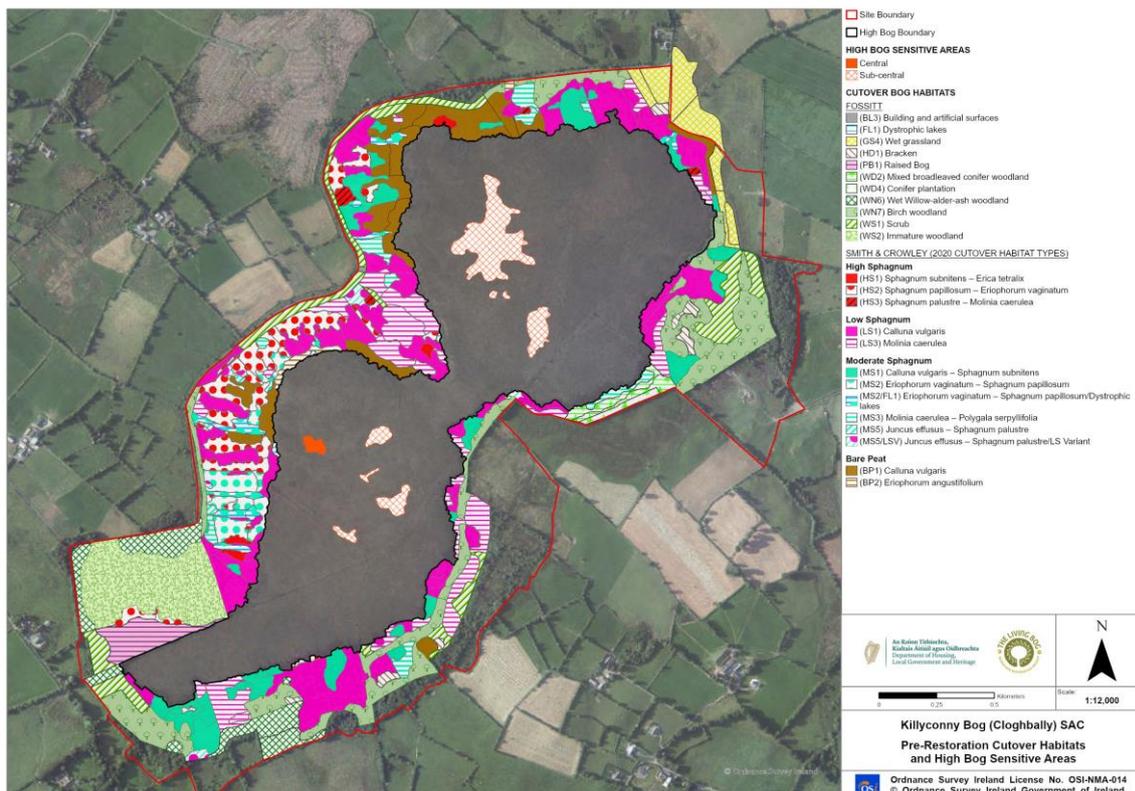
Figure 5.2 Ecological monitoring results (Pre-Restoration) at Killyconny Bog SAC illustrating high bog and cutover vegetation types. *Note* Post-Restoration results to be confirmed.

The most recent ecotope survey of Killyconny Bog SAC was completed in 2011. The site was not included in the sites resurveyed as part of the Living Bog Project; however, it will undergo ecotope survey as part of NPWS national monitoring surveys in future years. This will assess the extent of the impact of restoration measures on the high bog. In 2011, 3.9ha of ARB was mapped as occurring on the high bog, with 0.2ha comprising central ecotope and 3.7ha comprising sub-central ecotope.

In addition to the high bog survey, a methodology for detailed vegetation mapping of cutover habitats was developed as part of the Living Bog Project and published as Irish Wildlife Manual No. 128 'The Habitats of Cutover Raised Bog' (Smith & Crowley, 2020). A cutover survey carried out in accordance with this methodology was completed at Killyconny which identified that there are already 5.4ha of high *Sphagnum* areas throughout the cutover area largely as a result of past restoration measures. This area is expected to increase due to the measures implemented as part of the Living Bog project, particularly from enhanced measures such as cell bunding. The high bog and cutover surveys completed as part of the Living Bog Project provides a baseline status that can be used to monitor the results of restoration measures in future.

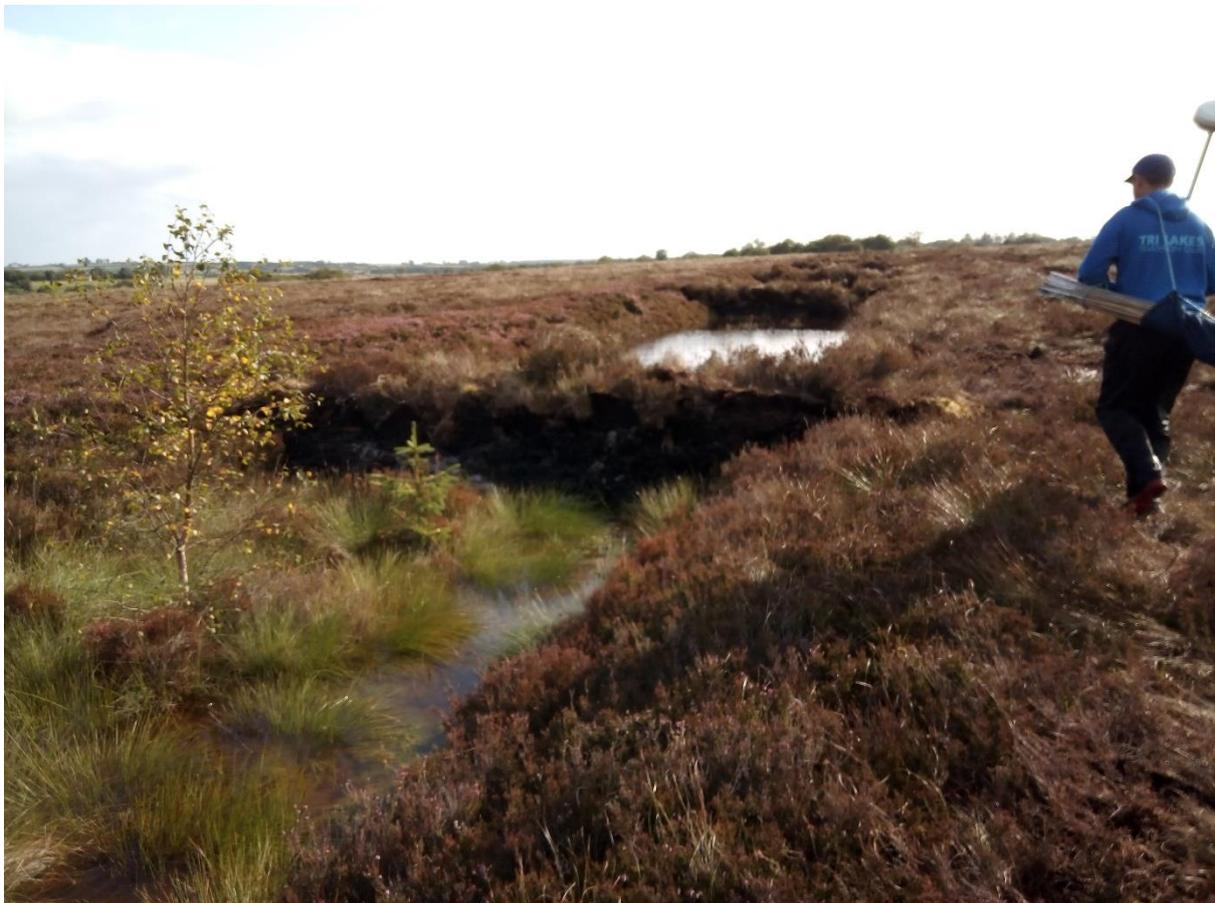
Figure 5.3 Example of setting out dams on an area of high bog

The surveying and staking out of drains and dams can be difficult due to the nature of the bog environment. Vegetation and soft ground conditions can make identification of features and surveying of same difficult and potentially dangerous. The setting out of the Works is generally done using bamboo stakes to mark the locations of the restoration measures that are to be constructed such as the dams or bunds. All Works carried out as part of the Living Bog Project of the restoration plan were set out as required which facilitated work being completed. This activity provides an additional opportunity to review the restoration measures in detail on the ground and where necessary minor modifications can be made (e.g., adjusting the placement of particular dams due to dense vegetation coverage or alignment of bunds due to ground conditions). This ensure that the risk of damage to the raised bog is minimized as inadequate planning can increase the risk of machines entering unsuitable areas.

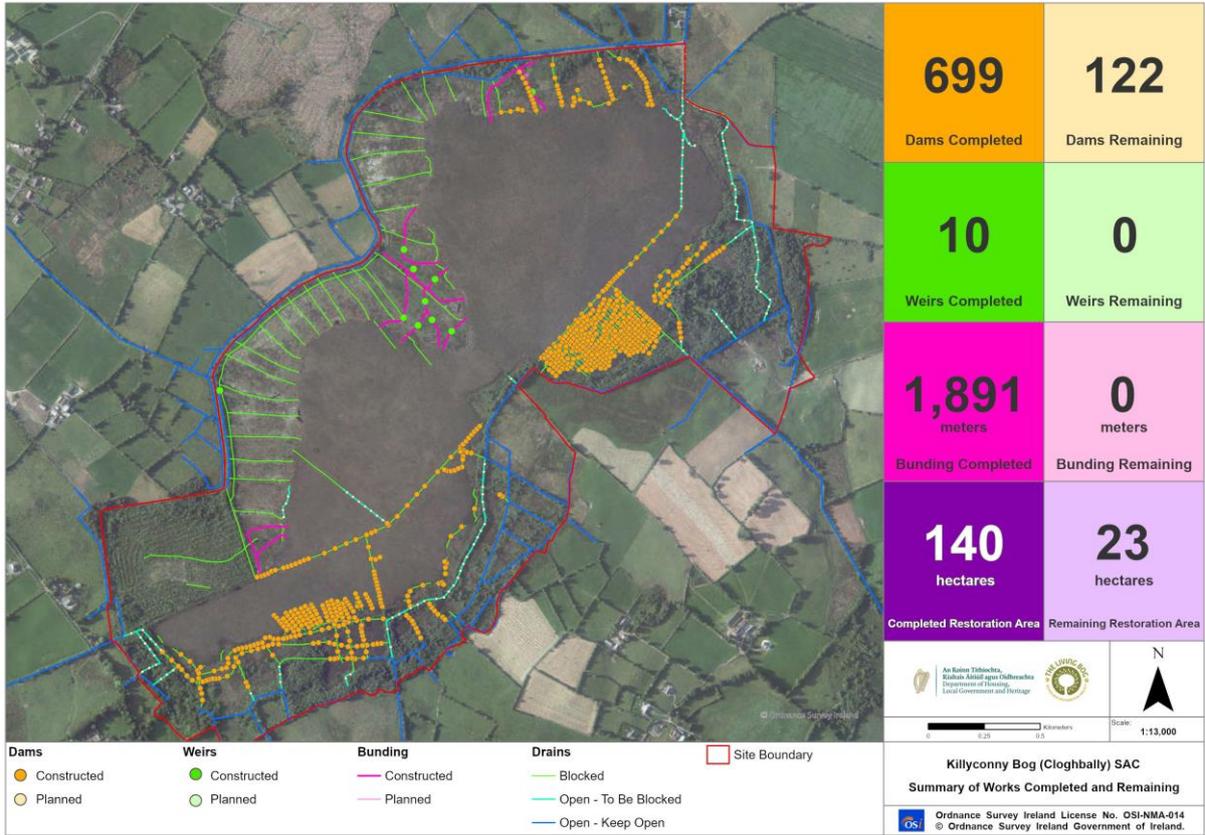
Figure 5.4 Summary of Works completed to date

All of the proposed as part of the Living Bog Project were completed as required at Killyconny Bog SAC. This includes construction of 556 dams, which were primarily constructed from peat but also included some plastic dams. In addition, a number of trial measures were completed at Killyconny including the construction of trial cell bunding in areas noted by Crowley et al. (2021) as being relatively dry and the installation of new outlets at the marginal dam on Killyconny. A techniques manual which details each of these methods including the methods developed through the Living Bog Project was produced as part of the project (Cushnan et al., 2022).

Post-Works inspections have been completed and an as-built drawing was prepared by Bord na Móna on behalf of the Living Bog Project (summarised in Figure 5.4). This included detailed aerial surveys of the bog to collect high-resolution ortho-imagery and to ensure a detailed as-built drawing could be prepared.

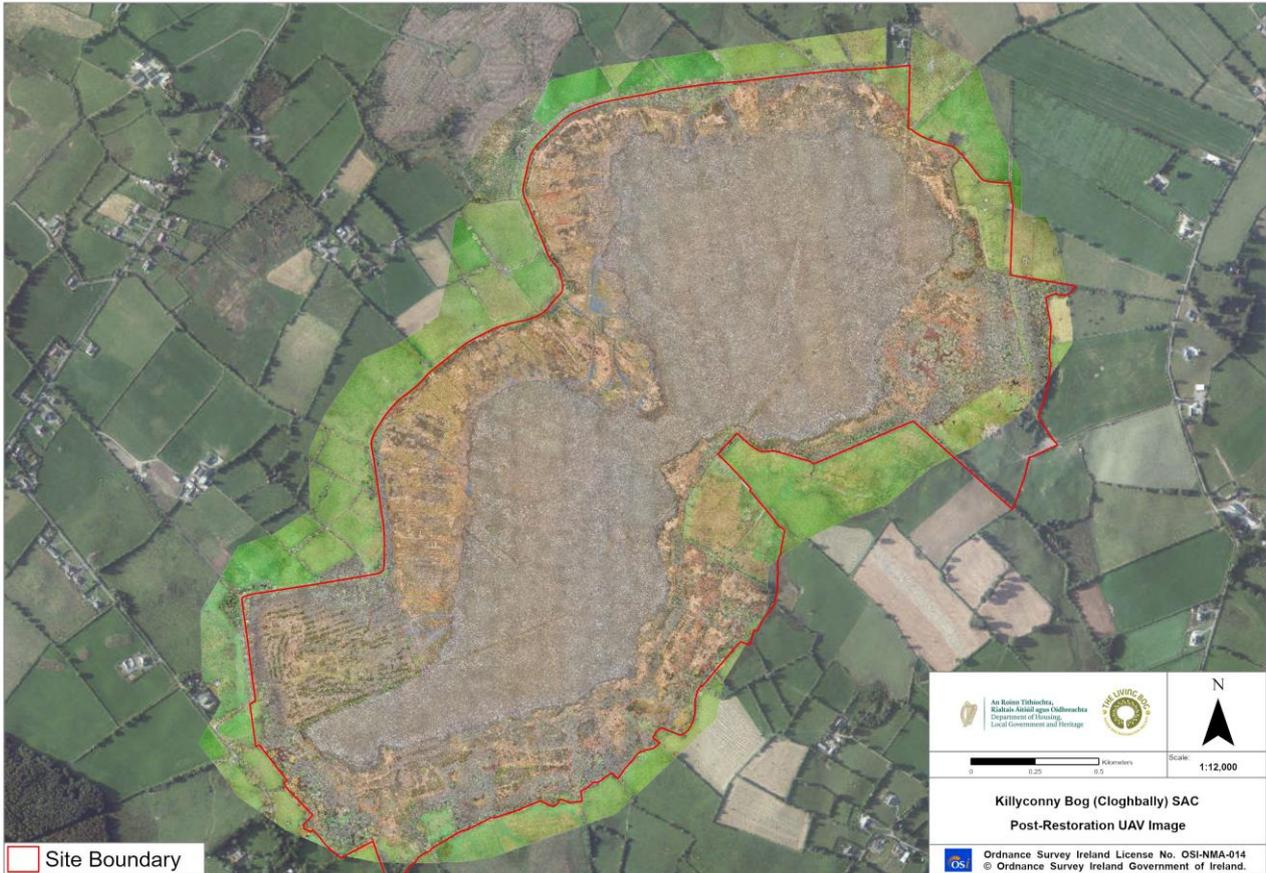
Figure 5.5 High resolution post-Works ortho imagery from UAV survey
