National Parks & Wildlife Service

Lisnageeragh Bog and Ballinastack  
Turlough SAC  
(Site code 000296)

**Raised Bog Restoration Plan (Report)**

October 2022

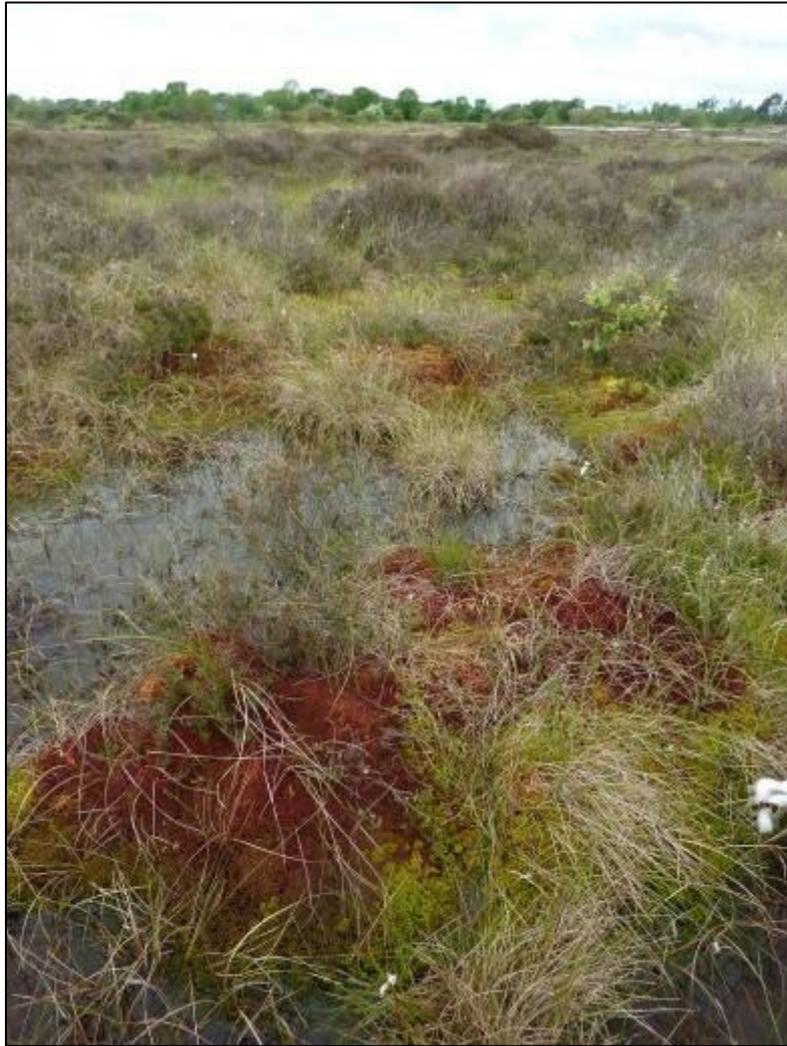
**Figure 2.2 Water table at the surface of cutover bog following successful drain blocking resulting in *Sphagnum* development less than 10 years after drain blocking (this was previously an area of bare peat)**

Blocking of cutover drains slows the flow of water off the cutover areas and increases the water table in the surrounding peat. This can help to reduce the rate of infiltration through the high bog and can lead to conditions that allow peat to form on the cutover (**Figure 2.2**).

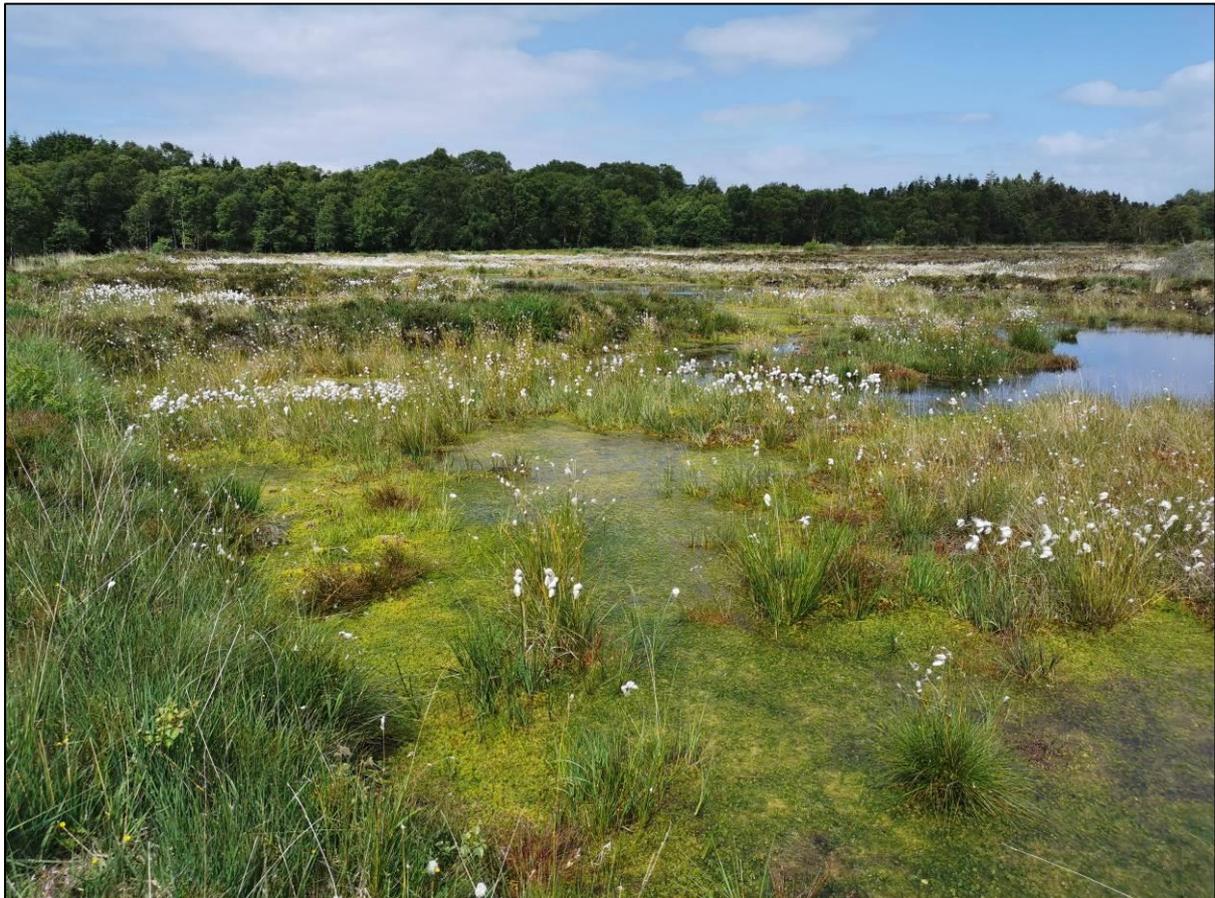
**Figure 2.3 Example of existing cell bund constructed at Cloncrow Bog NHA (The vegetation in this photo has developed in the 2 years since cell construction)**

Cell bunds are typically constructed by excavating a trench 1.0-1.5m deep, recompacting the excavated peat into the trench and constructing a bund 0.5-0.6m high above the ground surface (Figure 2.3). Water level control structures (pipes or overflow weirs) are incorporated into these cells as a means to regulate water levels and evenly distribute water across the site.

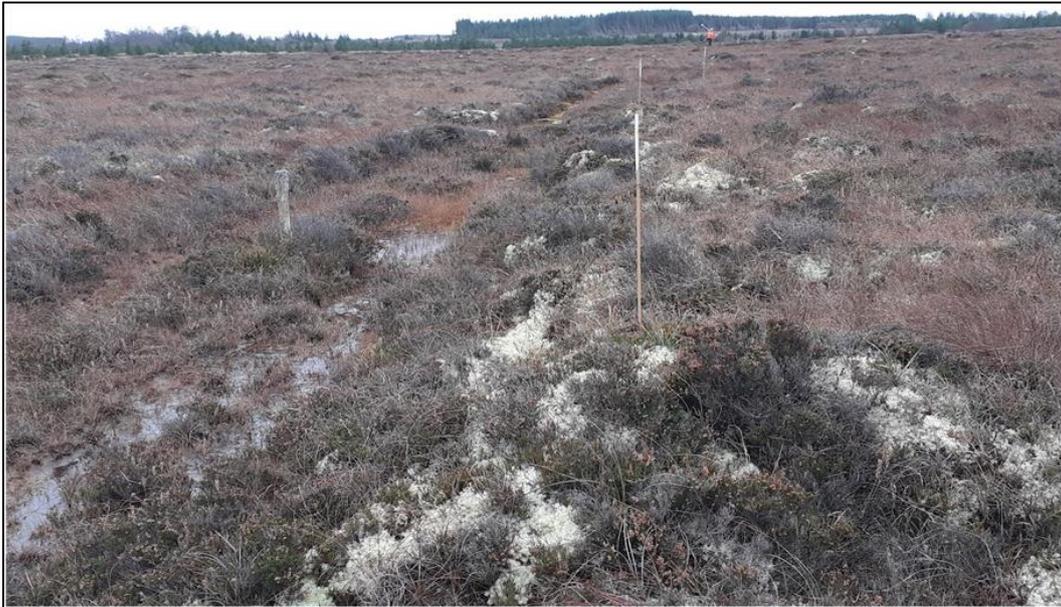
Figure 5.3 Example of setting out dams on an area of high bog

The surveying and staking out of drains and dams can be difficult due to the nature of the bog environment. Vegetation and soft ground conditions can make identification of features and surveying of same difficult and potentially dangerous. The setting out of the works is generally done using bamboo stakes to mark the locations of the restoration measures that are to be constructed such as the dams or bunds. All works proposed during phase 1 of the restoration plan were set out as required. This activity provides an additional opportunity to review the restoration measures in detail on the ground and where necessary minor modifications can be made (e.g., adjusting the placement of particular dams due to dense vegetation coverage or alignment of bunds due to ground conditions). This ensure that the risk of damage to the raised bog is minimized as inadequate planning can increase the risk of machines entering unsuitable areas.

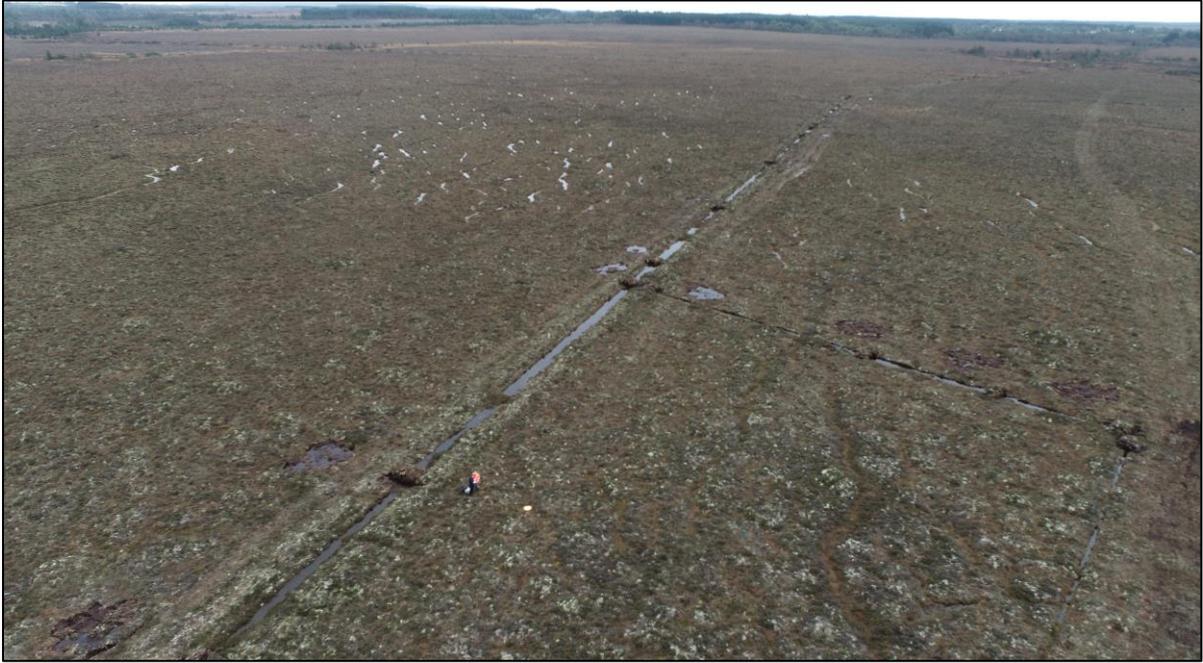
**Figure 5.5 Example of drain blocking with peat dams on the high bog**

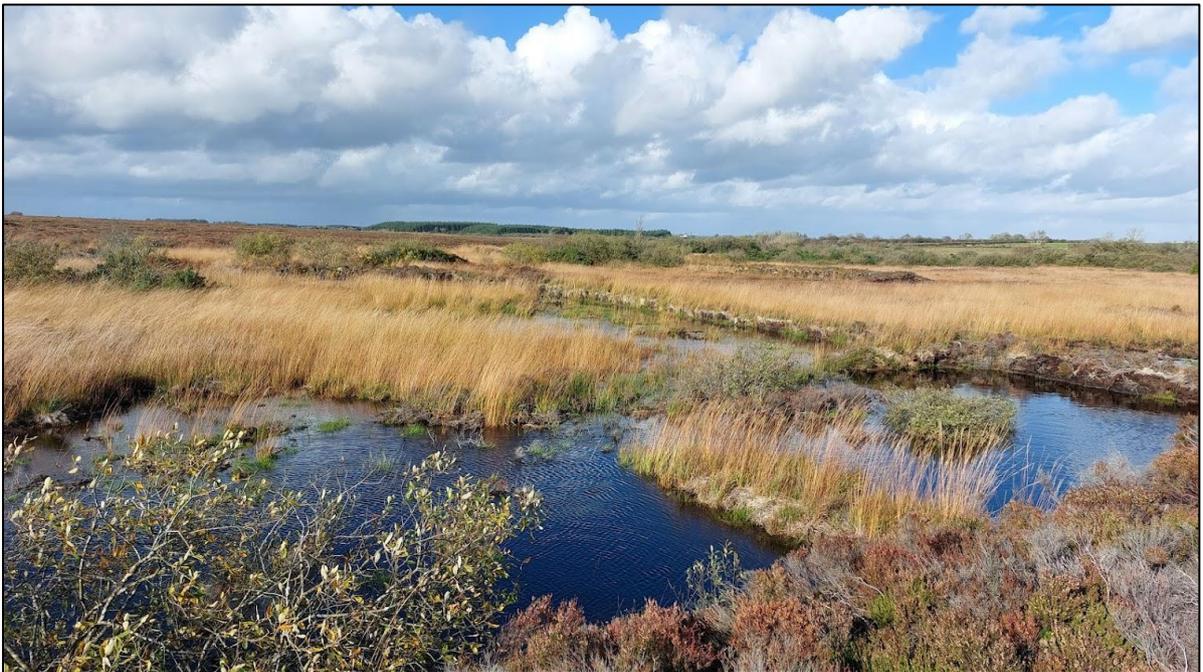
**Figure 5.6 Example of bunding on the cutover bog**
