Lough Corrib SAC (Addergoole Bog)
(Site code 000297)

Raised Bog Restoration Plan 9 (Report)

Version 2

October 2022

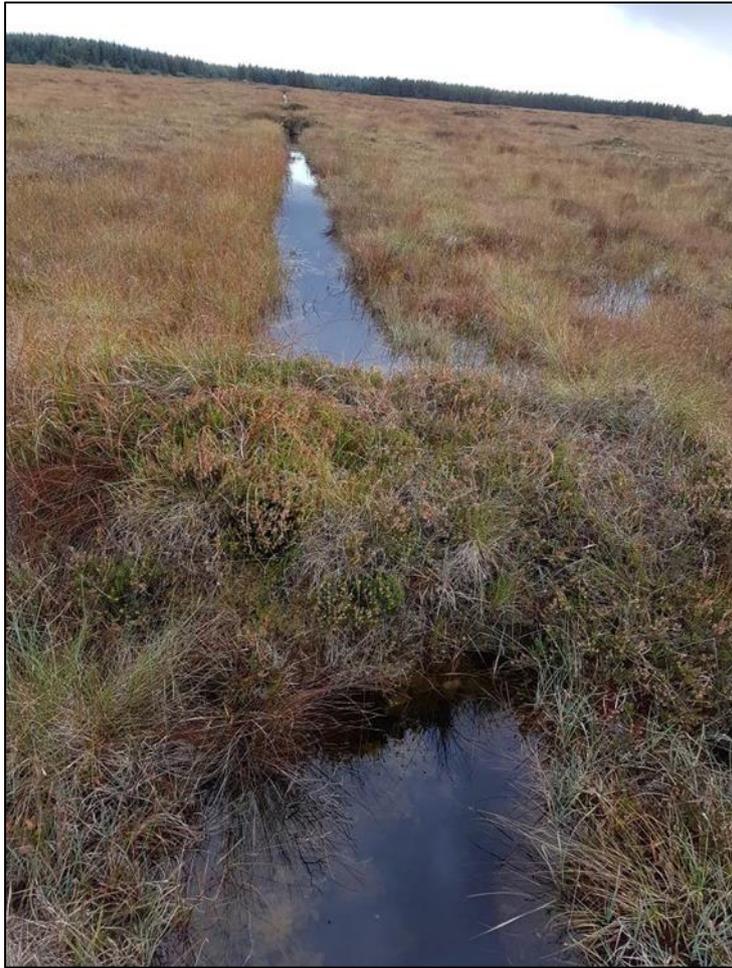
Figure 2.1 Example of a peat dam used to block a typical high bog drain.

Blocking high bog drains slows the flow of water off the surface of the bog and increases the water table in the peat. Drain blocking is a proven and effective restoration measure on Irish raised bogs with minimal maintenance requirements. The approach has been demonstrated at a number of raised bogs in Ireland with very positive results evident in less than 10 years (**Figure 2.1**) as outlined by Fernandez *et al.* (2014b).

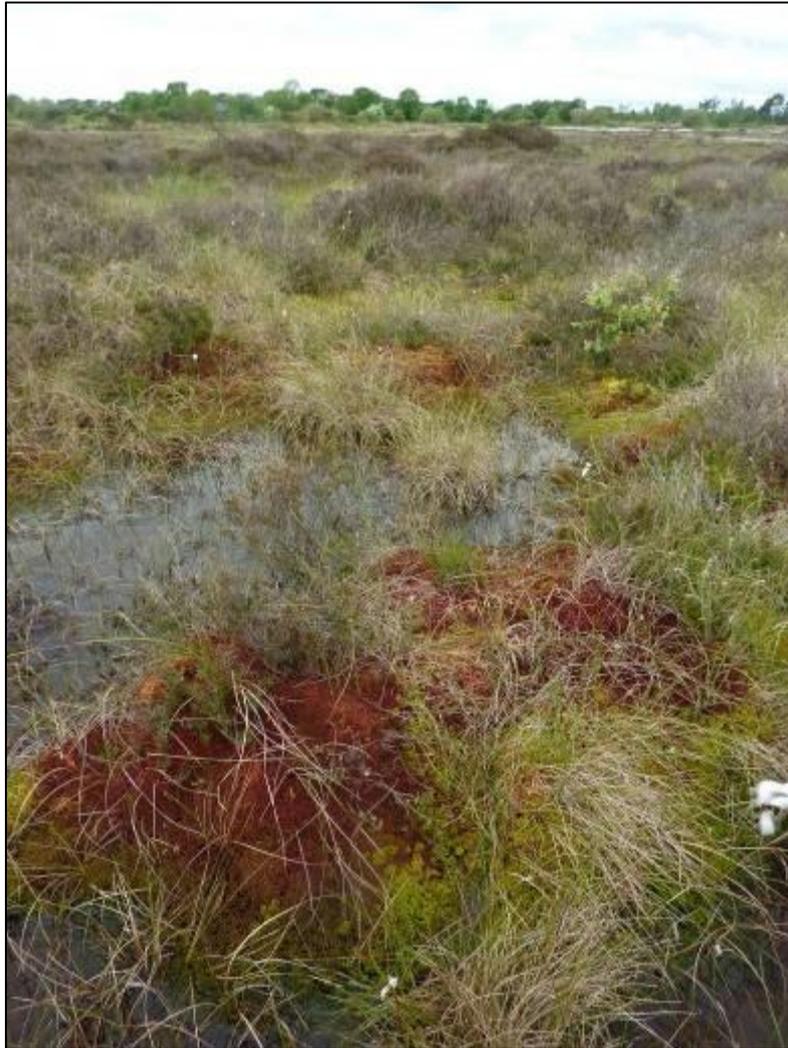
Figure 2.2 Water table at the surface of cutover bog following successful drain blocking resulting in *Sphagnum* development less than 10 years after drain blocking (this was previously an area of bare peat)

Blocking of cutover drains slows the flow of water off the cutover areas and increases the water table in the surrounding peat. This can help to reduce the rate of infiltration through the high bog and can lead to conditions that allow peat to form on the cutover (**Figure 2.2**).

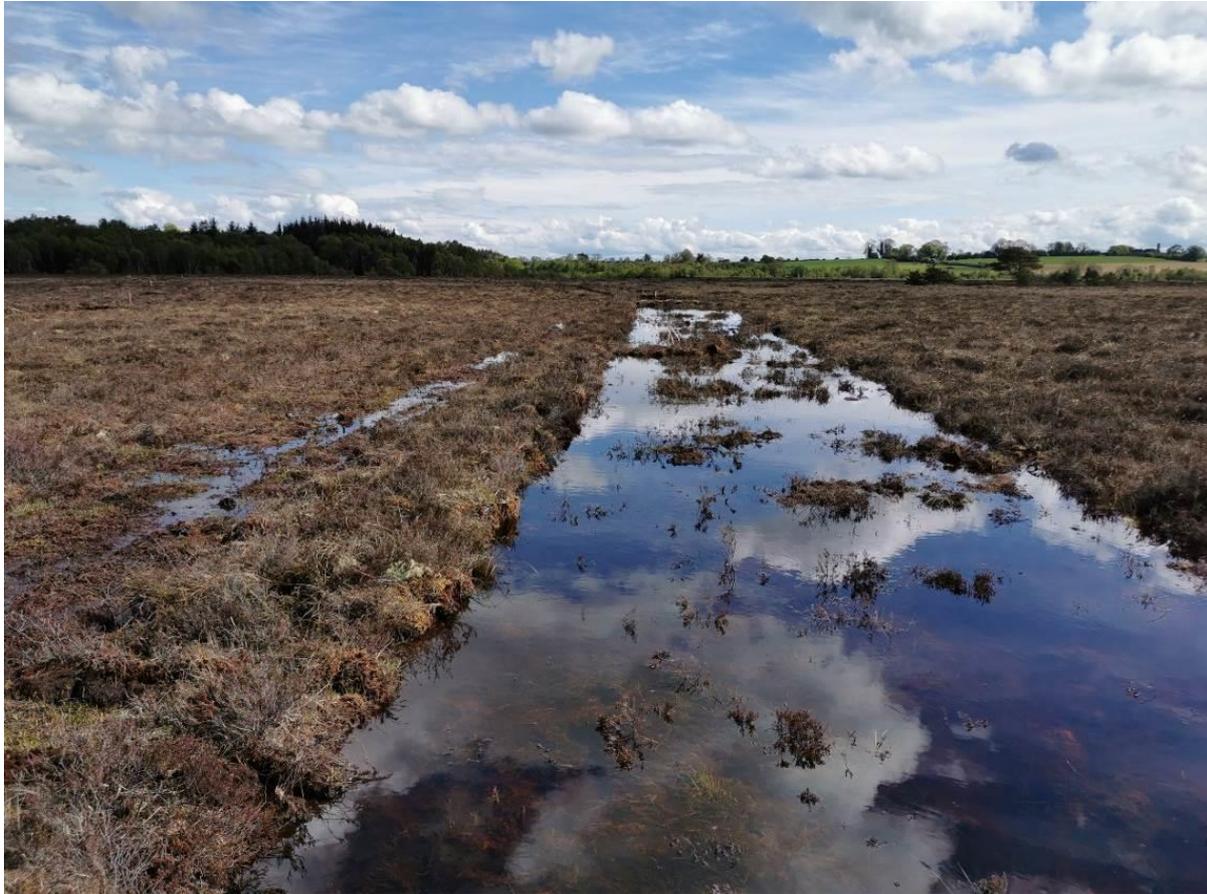
Figure 2.3 Contour bund constructed at Knockacoller Bog SAC, Co Laois

Contour bunds on the high bog aims to reduce the rate of lateral flow through the upper layers of the peat. In contrast to some other bunding techniques, contour bunding is not intended as a means of impounding surface water. This method involves excavating a trench 1.5-2.0m deep, re-compacting peat into the trench and building a slightly raised bund 25-30cm above the current ground surface. In

addition, these bunds have 5m long 'finger bunds' constructed using the same technique at approximately 25m spacing to prevent flow along the bund which may lead to erosion. After 1-2 years it is anticipated that the bund will have subsided close to current ground level and therefore will not appear as a prominent feature on the bog surface.

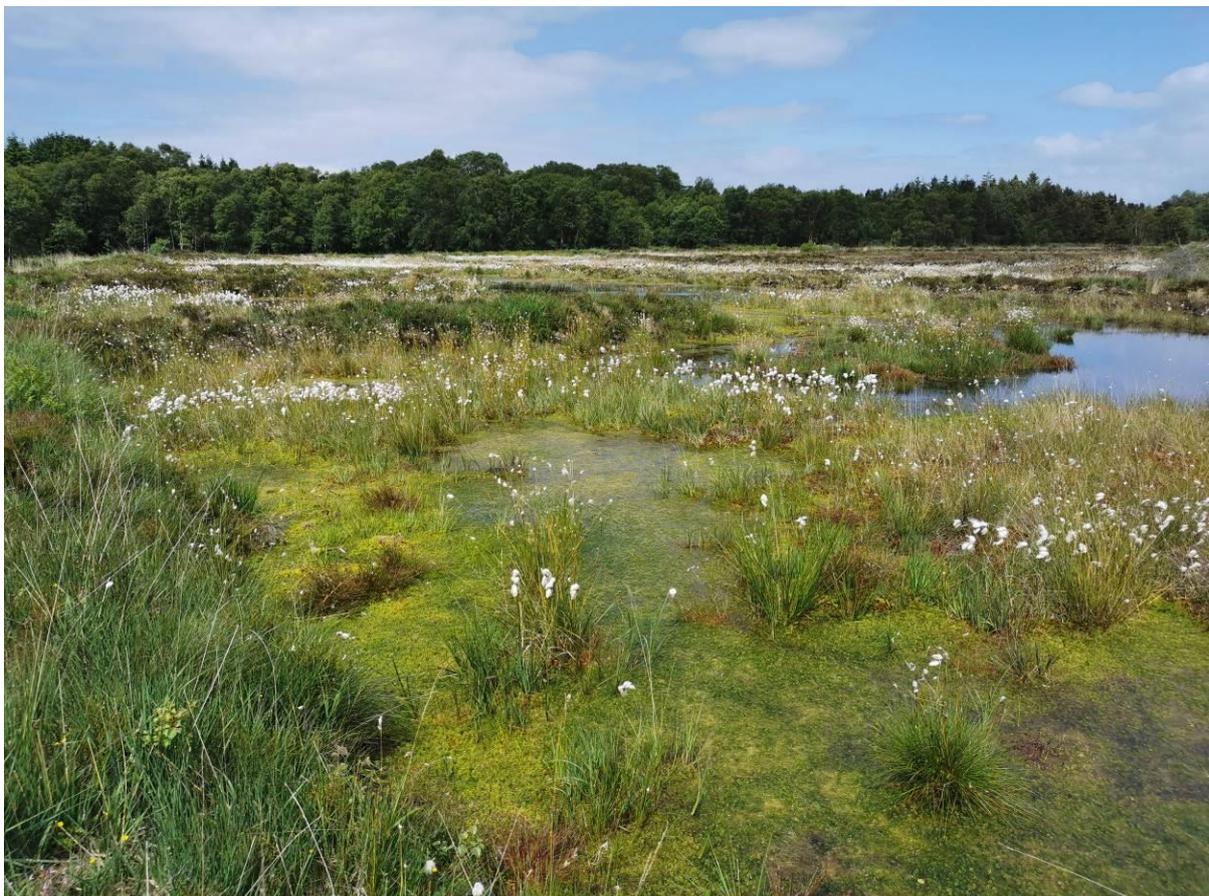
Figure 2.4 Example of existing cell bund constructed at Cloncrow Bog NHA (The vegetation in this photo has developed in the 2 years since cell construction)

Cell bunds are typically constructed by excavating a trench 1.0-1.5m deep, recompacting the excavated peat into the trench and constructing a bund 0.5-0.6m high above the ground surface (Figure 2.3). Water level control structures (pipes or overflow weirs) are incorporated into these cells as a means to regulate water levels and evenly distribute water across the site.

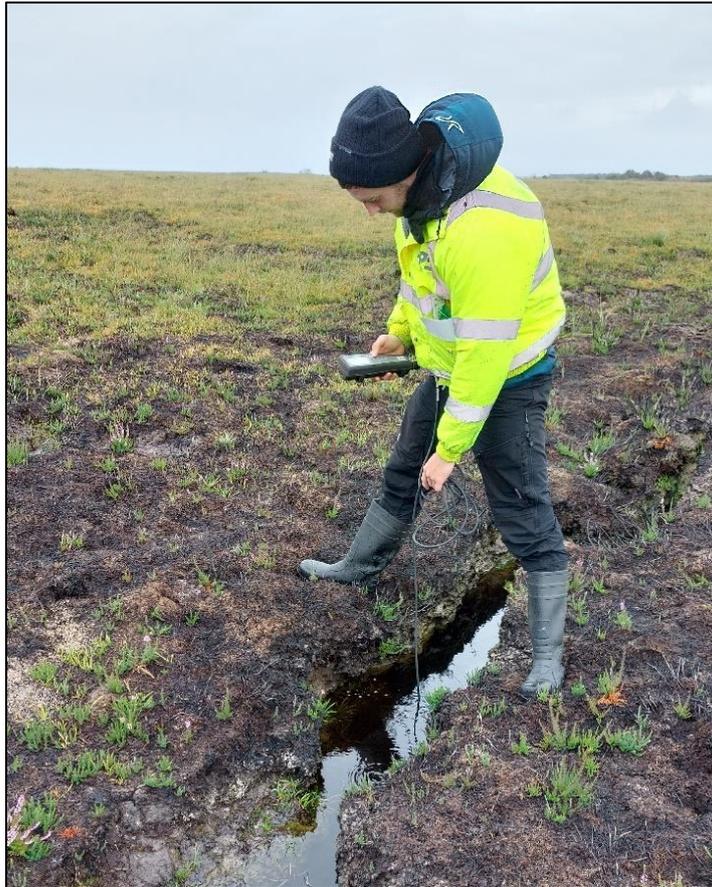
Figure 5.2 Example of Hydrologist checking conductivity of water within drains
