**Mongan Bog SAC**  
**(Site code 000580)**

**Raised Bog Restoration Plan (Report)**

Version 2

October 2022

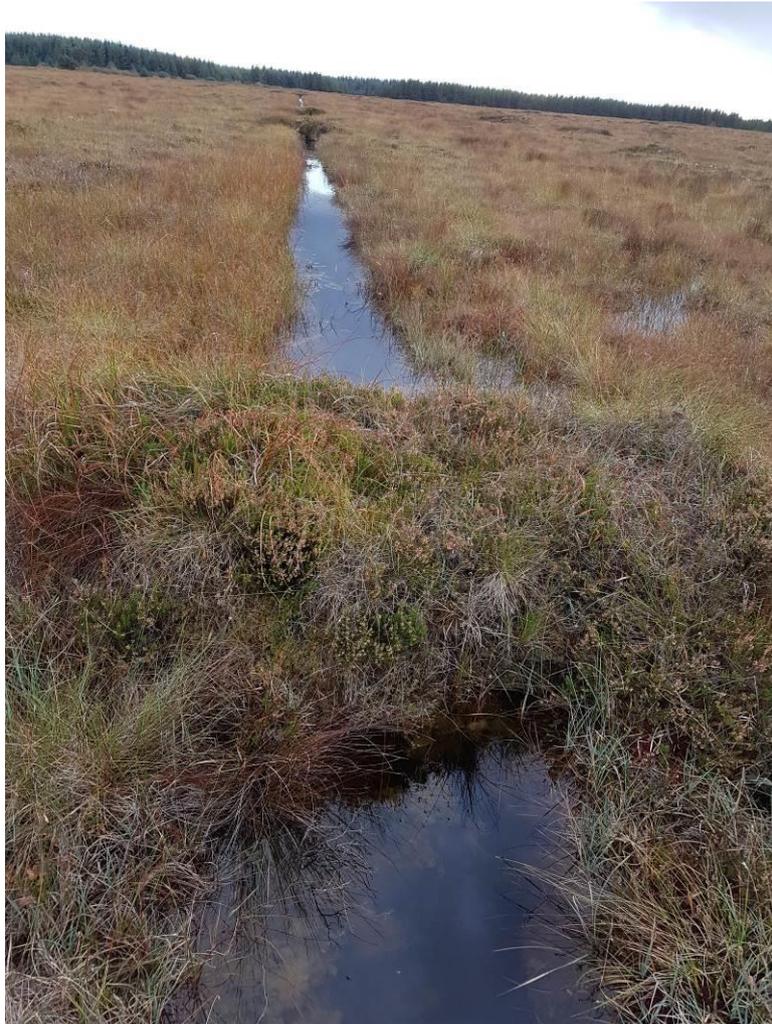
**Figure 2.1 Example of a peat dam to block a typical high bog drain**

Blocking high bog drains slows the flow of water off the surface of the bog and increases the water table in the peat. Drain blocking is a proven and effective restoration measure on Irish raised bogs with minimal maintenance requirements. The approach has been demonstrated at a number of raised bogs in Ireland with very positive results evident in less than 10 years (**Figure 2.1**) as outlined by Fernandez *et al.* (2014a).

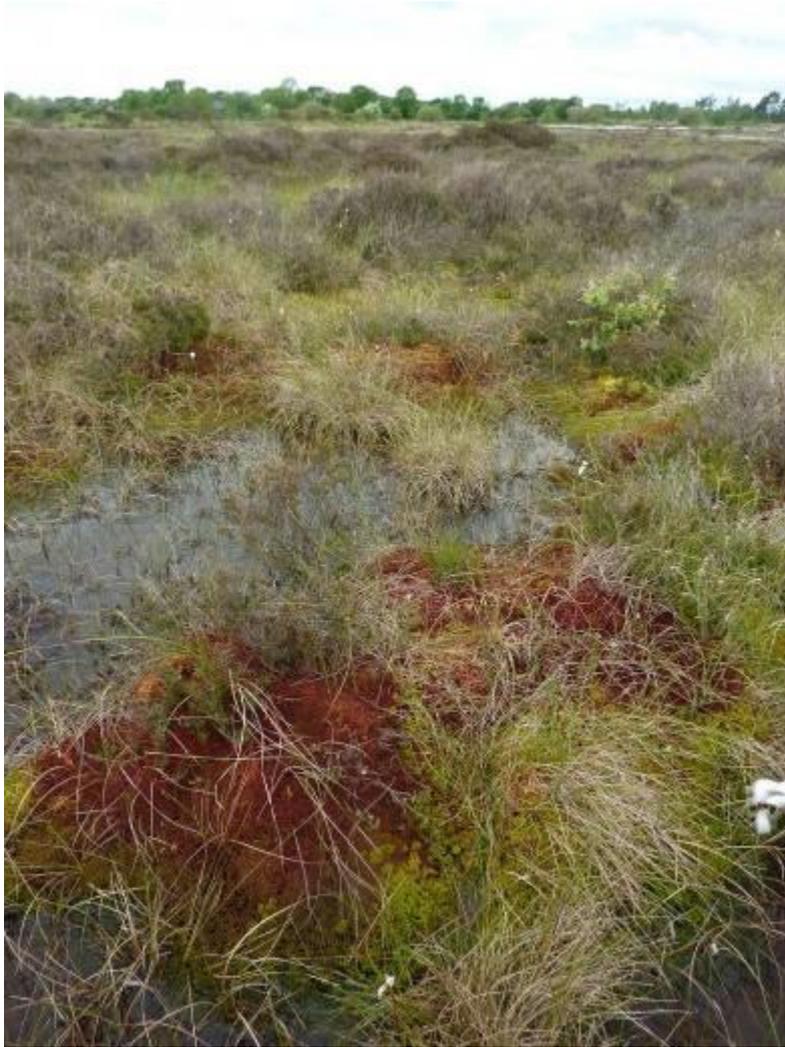
**Figure 2.2** Water table at the surface of cutover bog following successful drain blocking resulting in *Sphagnum* development less than 10 years after drain blocking (this was previously an area of bare peat)

Blocking of cutover drains slows the flow of water off the cutover areas and increases the water table in the surrounding peat. This can help to reduce the rate of infiltration through the high bog and can lead to conditions that allow peat to form on the cutover (**Figure 2.2**).

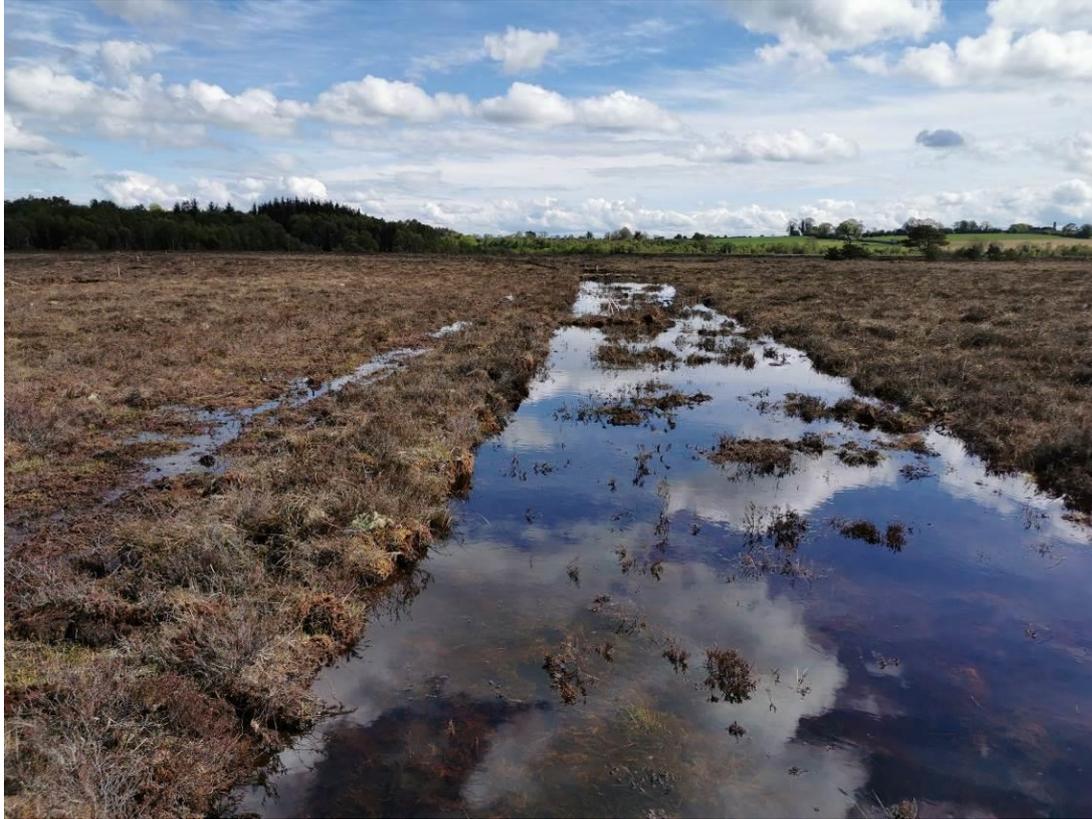
**Figure 2.3 Contour bund constructed at Knockacoller Bog SAC, Co. Laois**

of impounding surface water. This method involves excavating a trench 1.5-2.0m deep, re-compacting peat into the trench and building a slightly raised bund 25-30cm above the current ground surface. In addition, these bunds have 5m long 'finger bunds' constructed using the same technique at approximately 25m spacing to prevent flow along the bund which may lead to erosion. After 1-2 years it is anticipated that the bund will have subsided close to current ground level and therefore will not appear as a prominent feature on the bog surface.

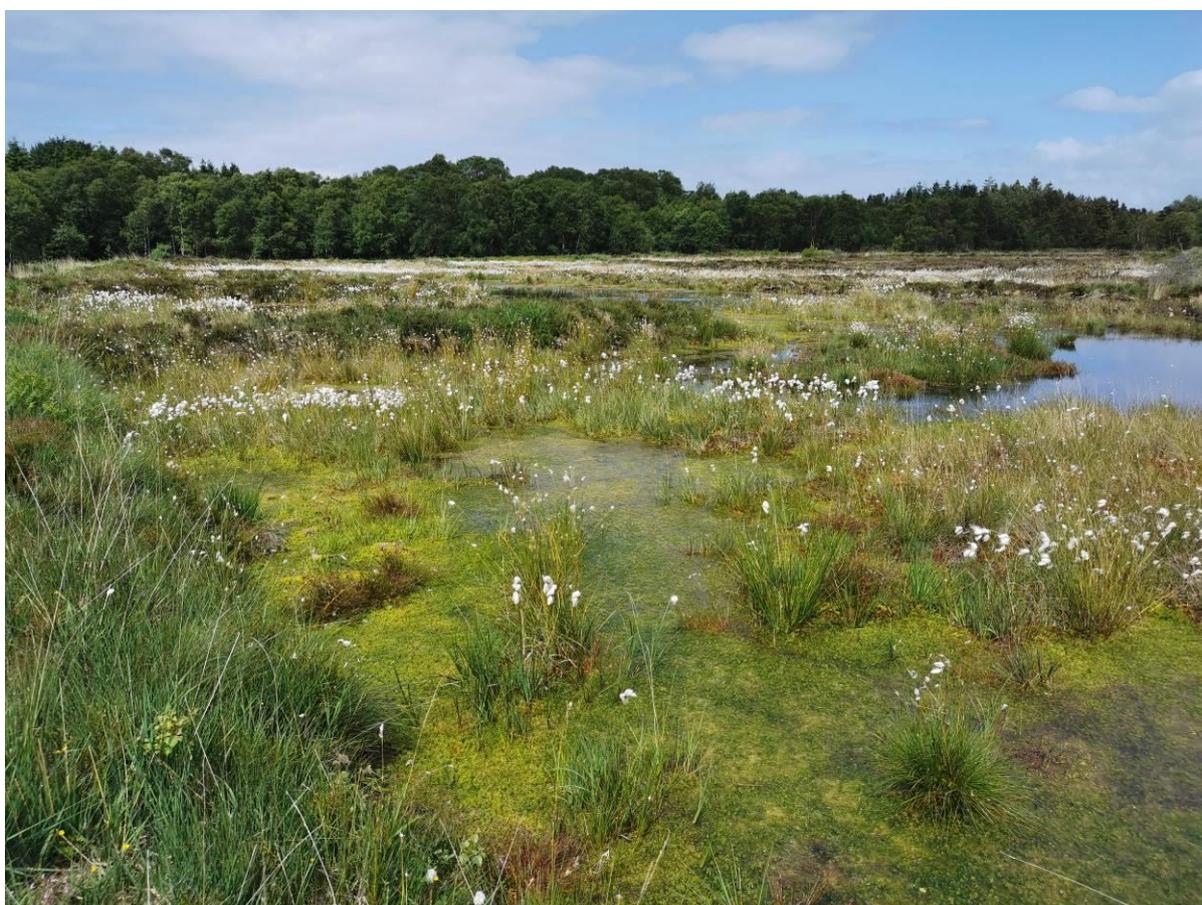
**Figure 2.4 Example of existing cell bund constructed at Cloncrow Bog NHA (The vegetation in this photo has developed in the 2 years since cell construction)**

Cell bunds are typically constructed by excavating a trench 1.0-1.5m deep, recompacting the excavated peat into the trench and constructing a bund 0.5-0.6m high above the ground surface (Figure 2.4). Water level control structures (pipes or overflow weirs) are incorporated into these cells as a means to regulate water levels and evenly distribute water across the site.

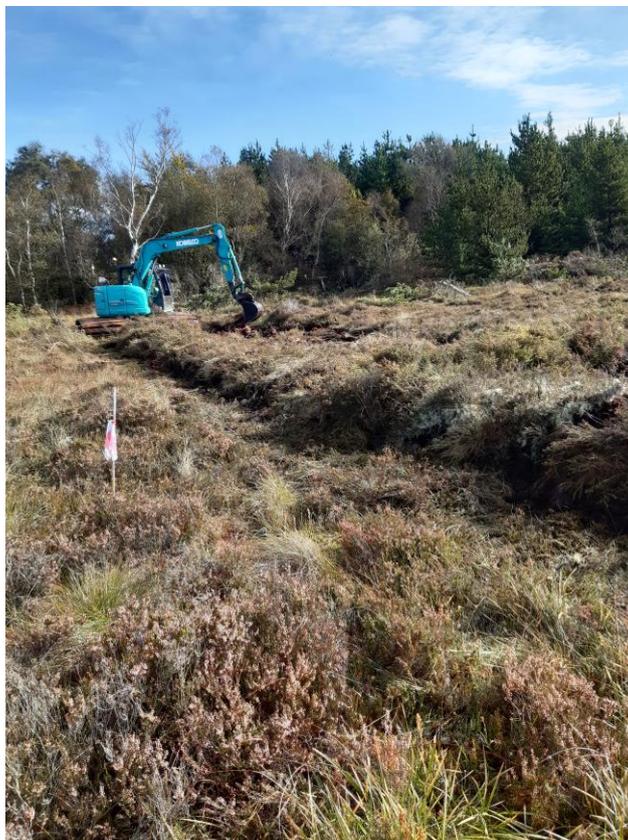
Figure 5.5 Example of setting out trench bunding on a cutover with bamboos and tape

The surveying and staking out of drains and dams can be difficult due to the nature of the bog environment. Vegetation and soft ground conditions can make identification of features and surveying of same difficult and potentially dangerous. The setting out of the Works is generally done using bamboo stakes to mark the locations of the restoration measures that are to be constructed such as the dams or bunds. All Works proposed during the Living Bog Project of the restoration plan were set out as required. This activity provides an additional opportunity to review the restoration measures in detail on the ground and where necessary minor modifications can be made (e.g., adjusting the placement of particular dams due to dense vegetation coverage or alignment of bunds due to ground conditions). This ensure that the risk of damage to the raised bog is minimized as inadequate planning can increase the risk of machines entering unsuitable areas.

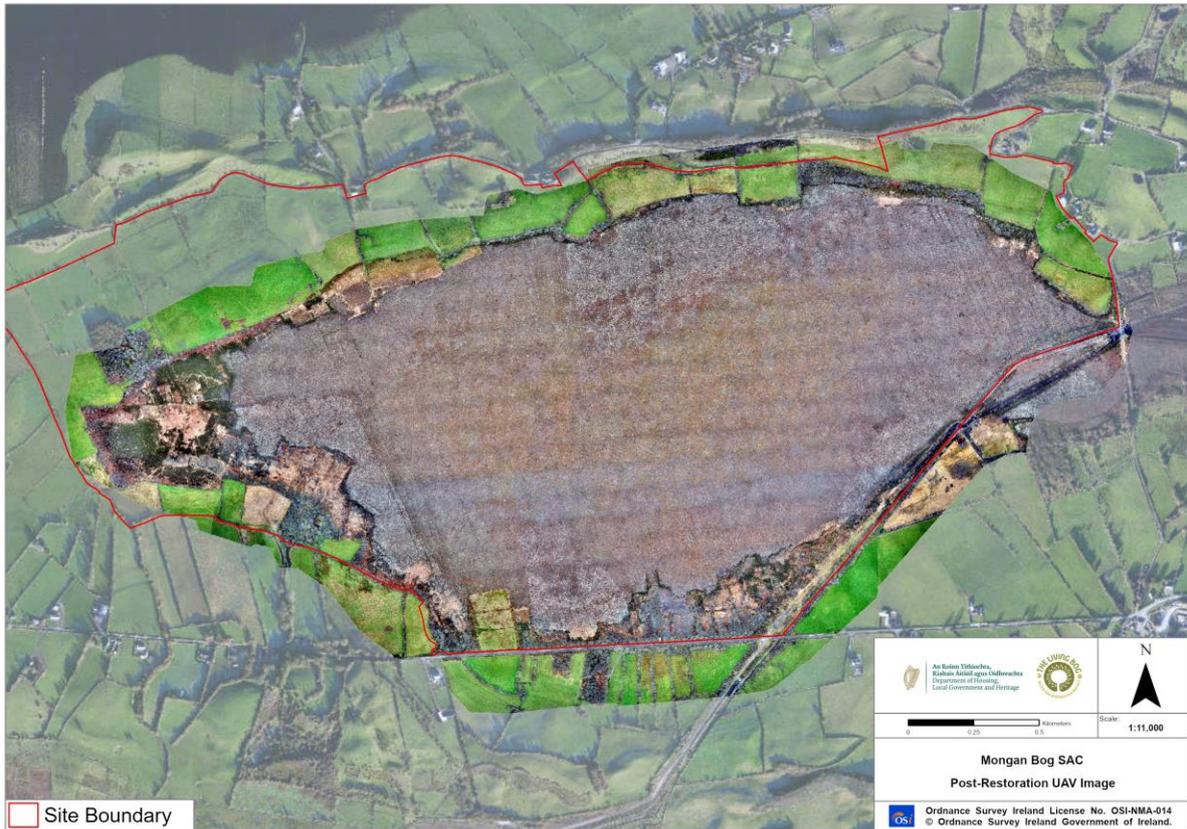
Figure 5.7 High resolution post-Works ortho imagery from UAV survey

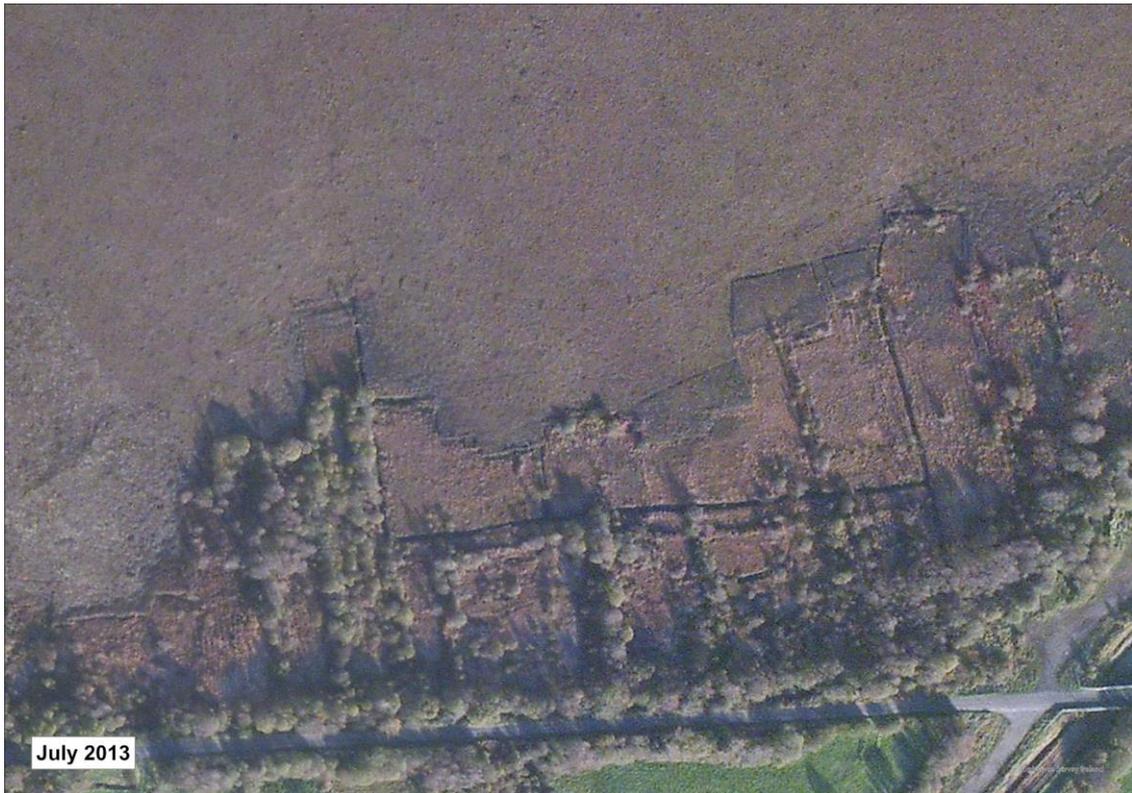
Figure 5.8 High resolution pre-Works ortho imagery from UAV survey
