National Parks & Wildlife Service

Moyclare Bog SAC
(Site code 000581)

Raised Bog Restoration Plan (Report)

October 2022

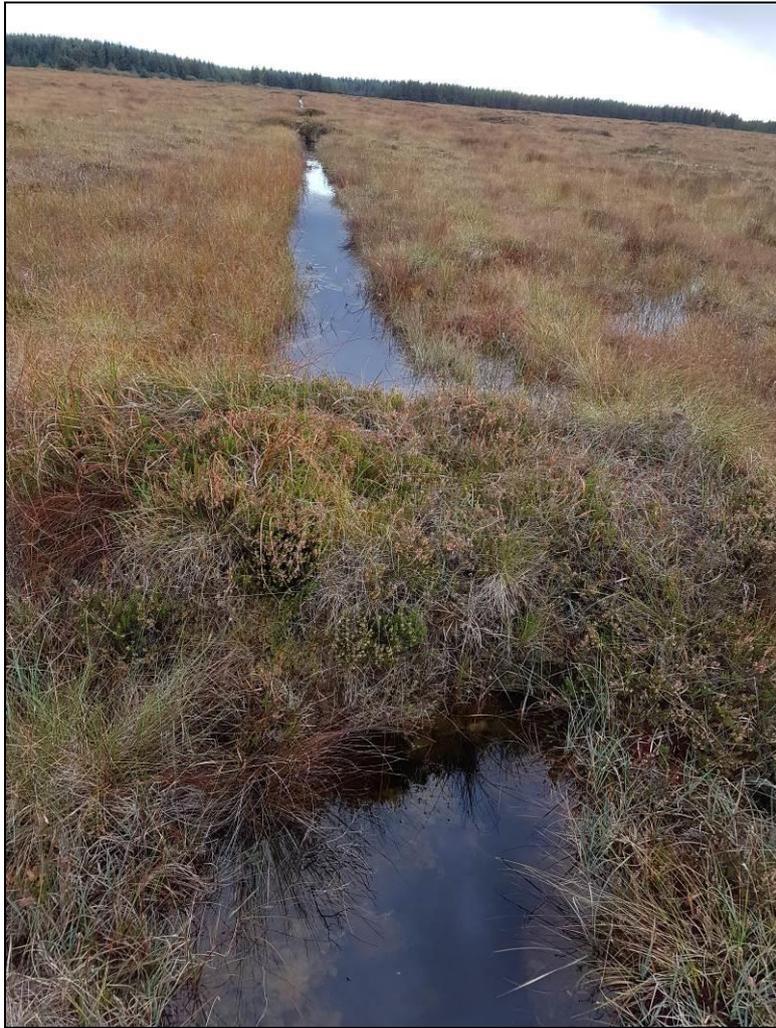
Figure 2.1 Example of a peat dam to block a typical high bog drain

Blocking high bog drains slows the flow of water off the surface of the bog and increases the water table in the peat. Drain blocking is a proven and effective restoration measure on Irish raised bogs with minimal maintenance requirements. The approach has been demonstrated at a number of raised bogs in Ireland with very positive results evident in less than 10 years (**Figure 2.1**) as outlined by Fernandez *et al.* (2014a).

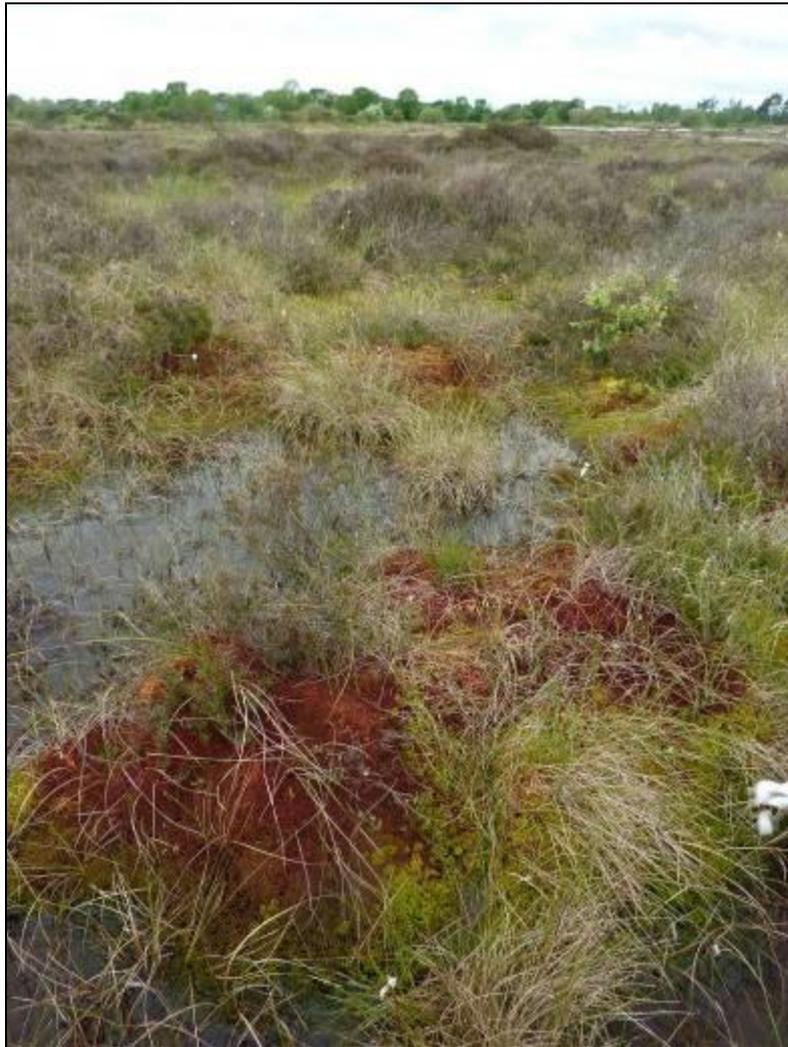
Figure 2.2 Water table at the surface of cutover bog following successful drain blocking resulting in *Sphagnum* development less than 10 years after drain blocking (this was previously an area of bare peat)

Blocking of cutover drains slows the flow of water off the cutover areas and increases the water table in the surrounding peat. This can help to reduce the rate of infiltration through the high bog and can lead to conditions that allow peat to form on the cutover (**Figure 2.2**).

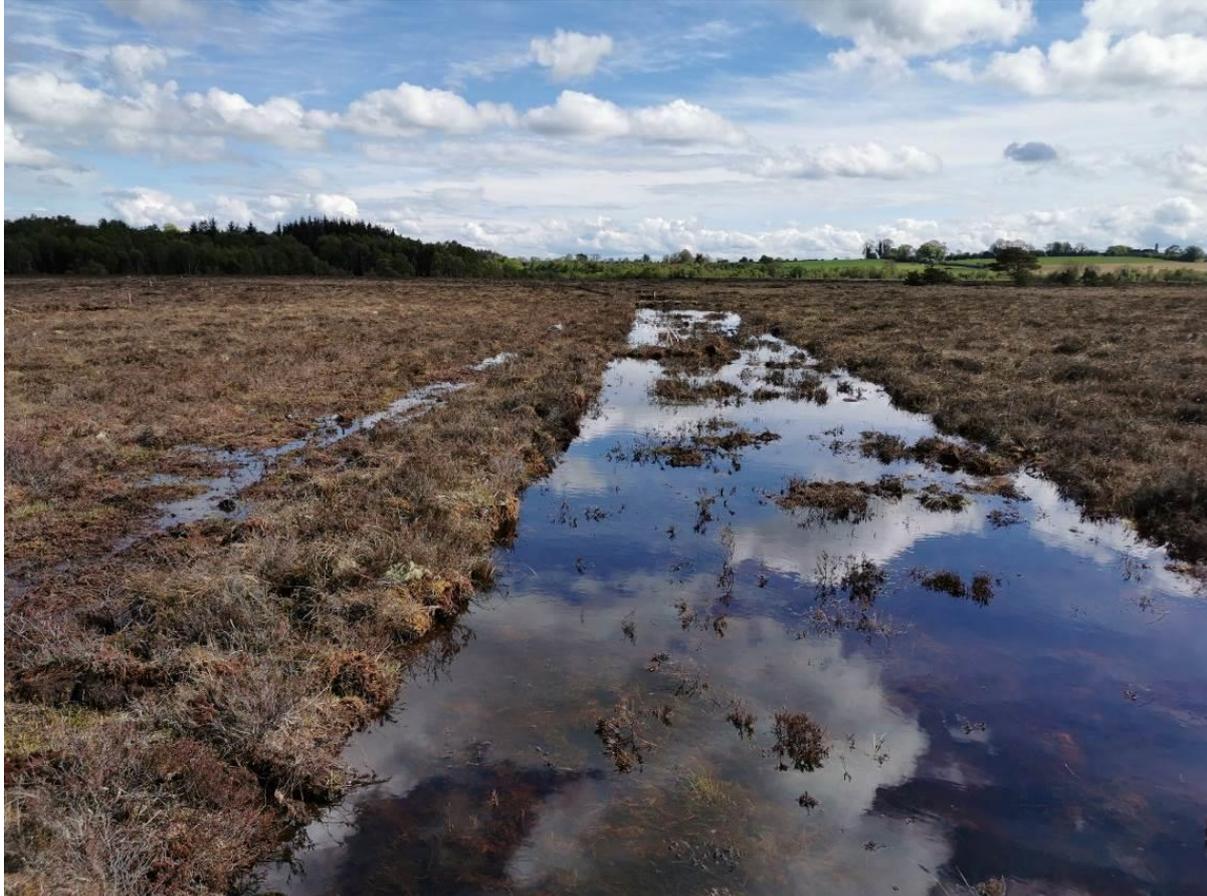
Figure 2.3 Contour bund constructed at Knockacoller Bog SAC, Co Laois

Contour bunds on the high bog aims to reduce the rate of lateral flow through the upper layers of the peat. In contrast to some other bunding techniques, contour bunding is not intended as a means of impounding surface water. This method involves excavating a trench 1.5-2.0m deep, re-

compacting peat into the trench and building a slightly raised bund 25-30cm above the current ground surface. In addition, these bunds have 5m long ‘finger bunds’ constructed using the same technique at approximately 25m spacing to prevent flow along the bund which may lead to erosion. After 1-2 years it is anticipated that the bund will have subsided close to current ground level and therefore will not appear as a prominent feature on the bog surface.

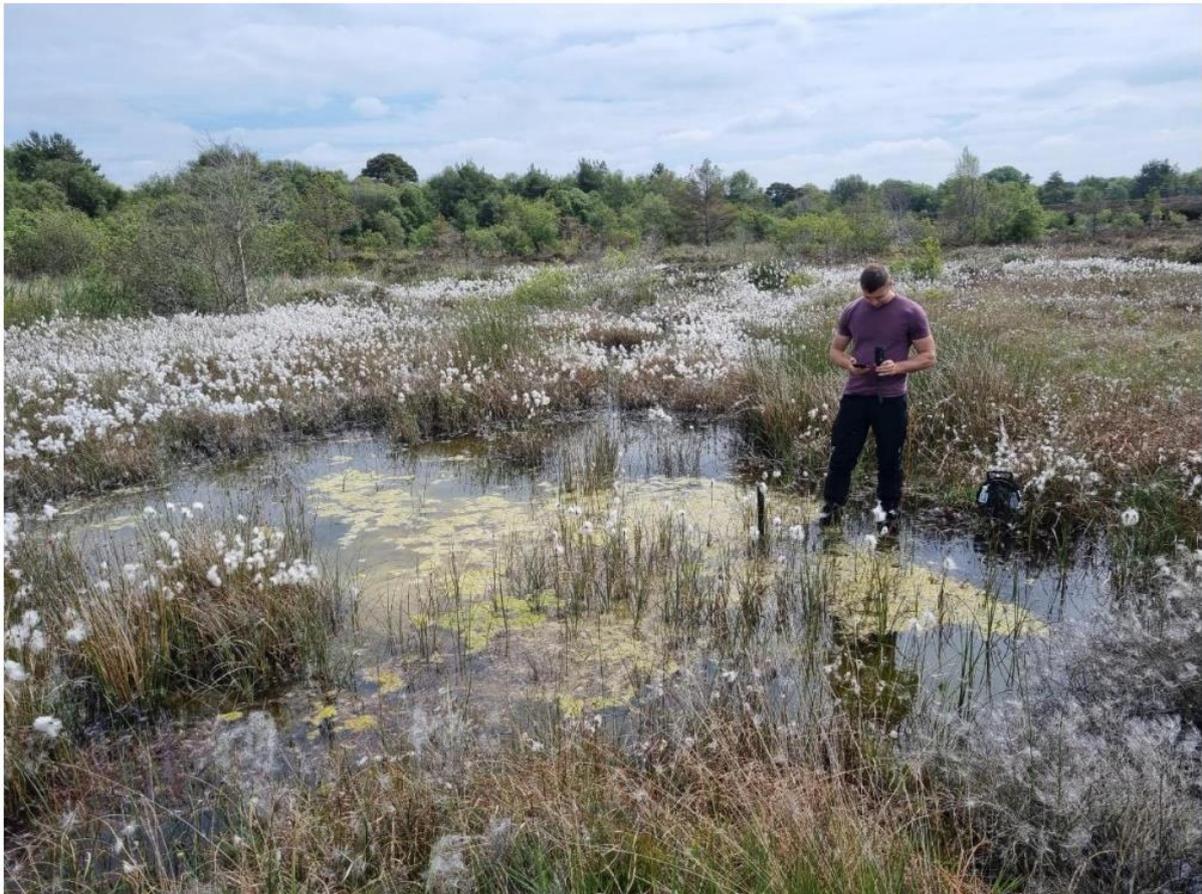
Figure 5.5 Example of significant rewetting on the cutover associated with drain blocking

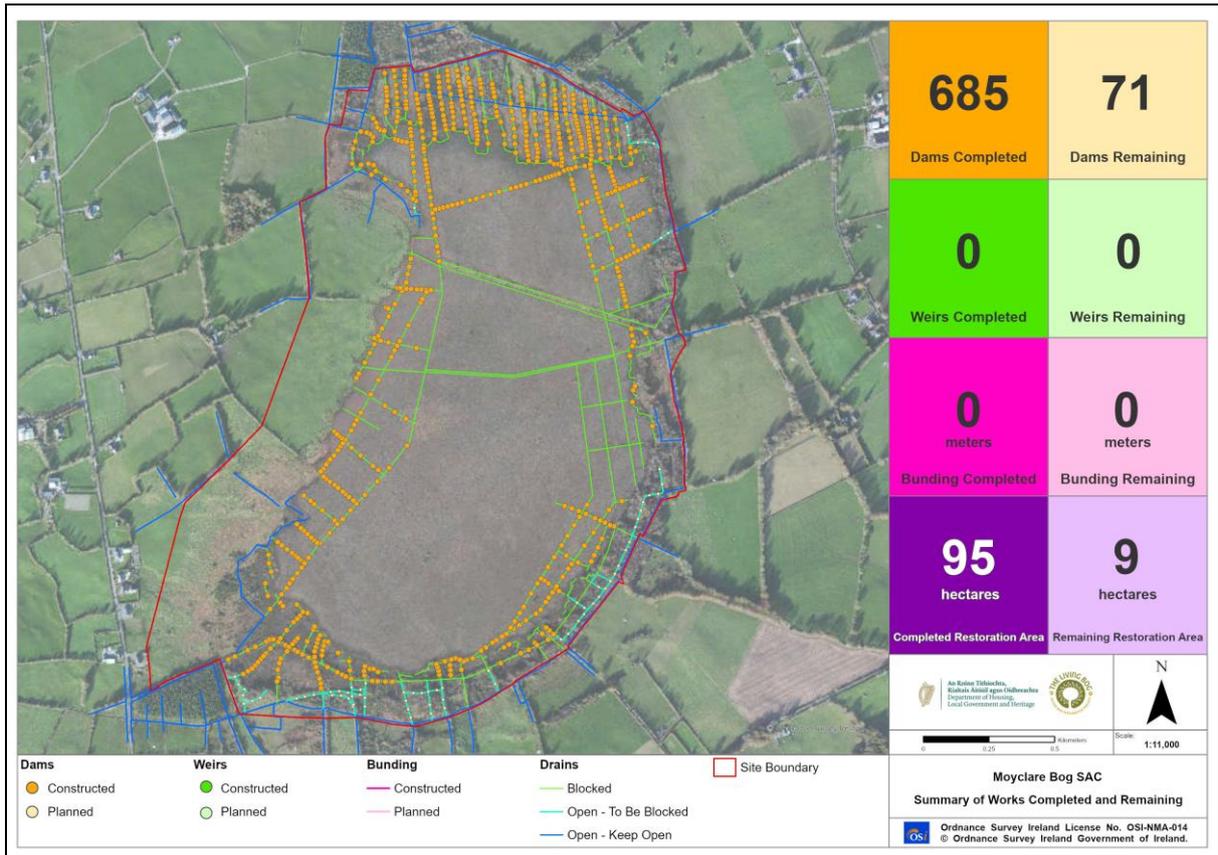
Figure 5.6 Summary of works completed to date

Almost all of the measures proposed as part of the Living Bog Project were completed as required at Moyclare Bog SAC. This includes construction of 1,117 dams, which were primarily constructed from peat but also included some plastic dams. A techniques manual which details each of these methods including the methods developed through the Living Bog Project was produced as part of the project (Cushnan et al., 2022).

Post-works inspections have been completed and an as-built drawing was prepared by Bord na Móna on behalf of the Living Bog Project (summarised in Figure 5.). This included detailed aerial surveys of the bog to collect high-resolution ortho-imagery and to ensure a detailed as-built drawing could be prepared.
